HISTORIC STRUCTURES REPORT

GRANT RANCH HOUSE COMPLEX

JOSEPH D. GRANT COUNTY PARK

Final Report
November 7, 2012

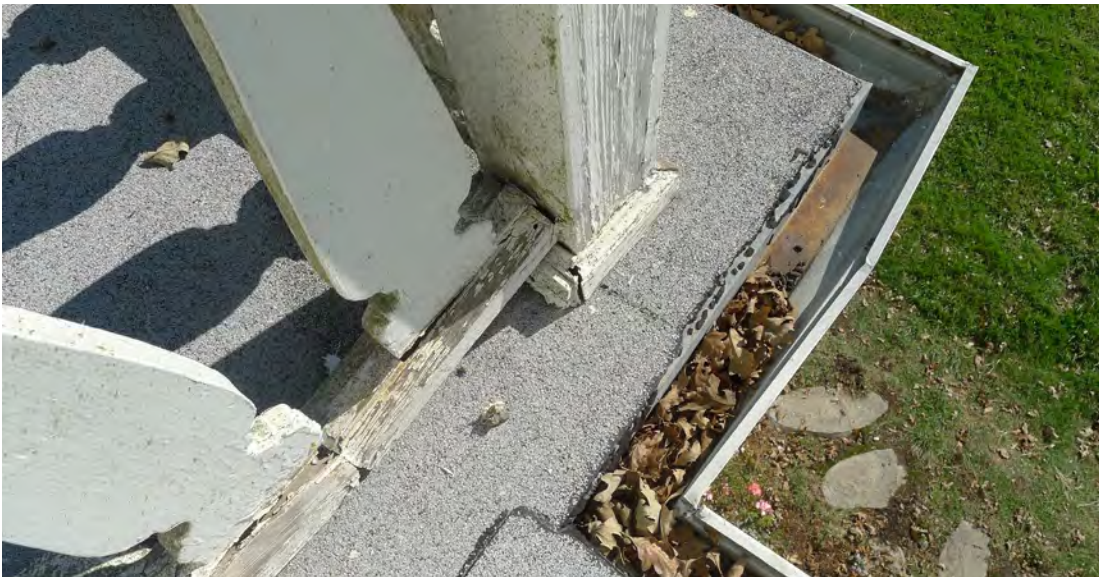
Figure 68. Gutter filled with debris.

ture problems on the exterior envelope (figure 70) and on the interior of the building. Where visible from above, gutters were found to be filled with debris (figure 68). Flashing between different roof sections is missing or severely deteriorated. The lack of proper flashing has caused wood in these areas to lose paint and deteriorate. Several downspouts are detached and leaking, contributing to the staining and biological growth on the wood siding and eaves. Poor site drainage has caused the shiplap siding closest to the soil to deteriorate. In a few areas the gutters are leaking causing water to run down the siding.

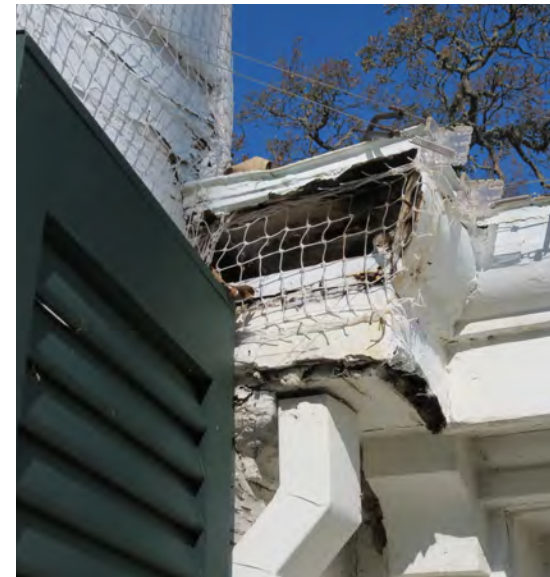
Figure 69. Gutter missing decorative wood molding.

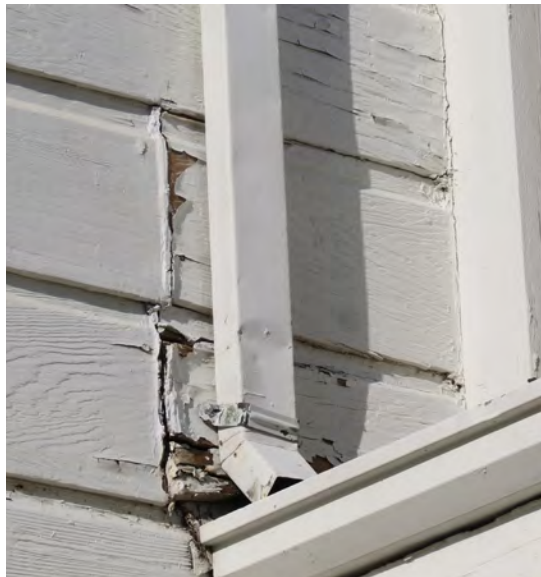
Figure 70. Damaged wood siding at downspout.

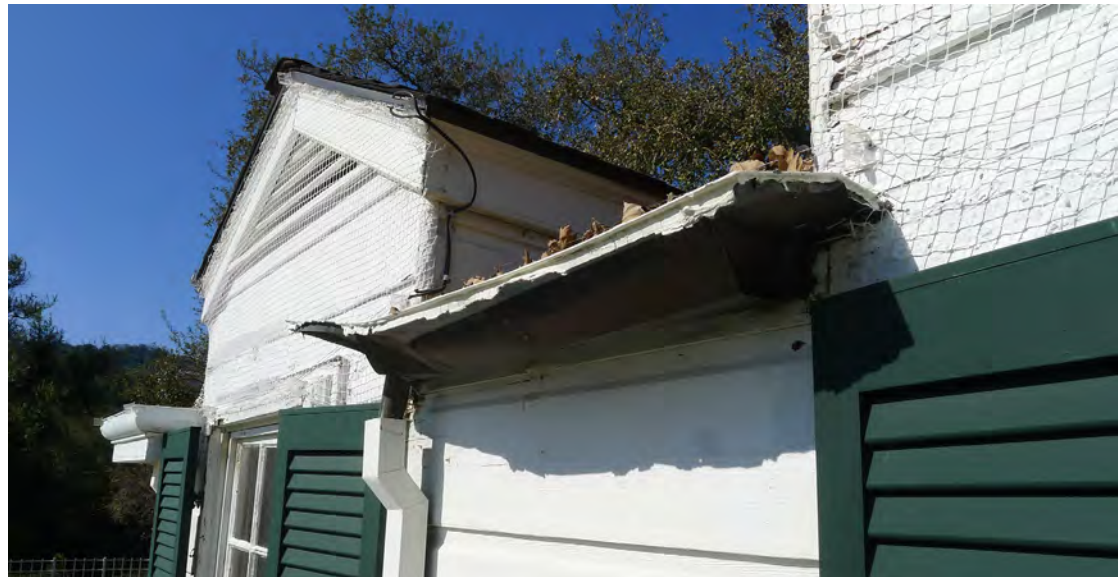
Figure 71. Gutter missing decorative wood molding.

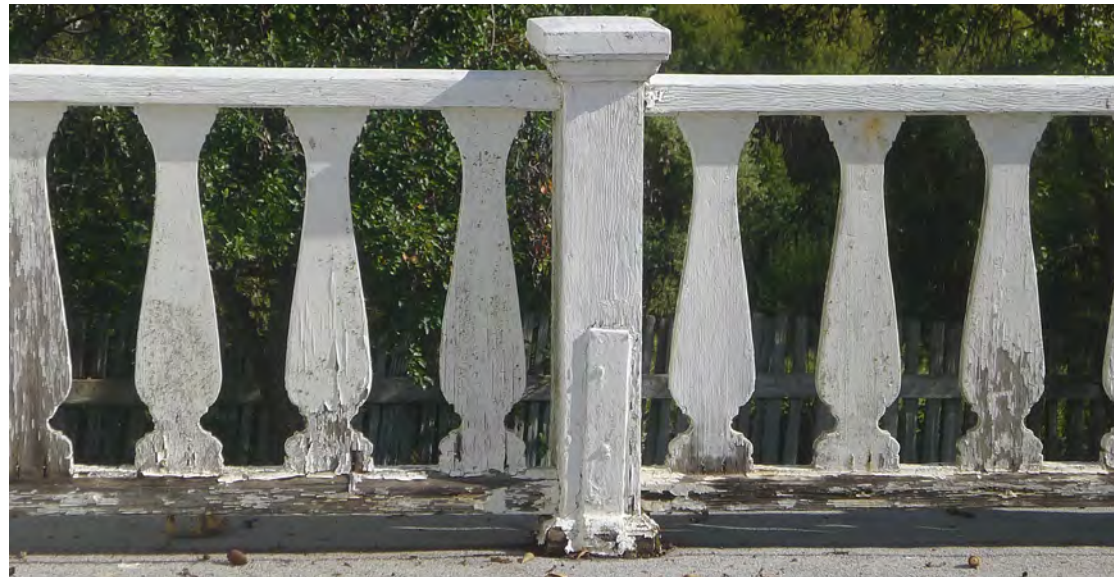
Figure 84. Severely damaged wood railing at balcony.

- Survey the balcony railing, cap rail and balusters for cracked, missing, or deteriorated pieces. Determine the extent of replacement.
- Repair and replace deteriorated wood rail cap and baluster sections with wood Dutchman or epoxy consolidant and fill. Where deterioration is severe, replace with in-kind materials, and profiles. The current railing is less than 42", the code-mandated height for guardrails. If proposed work triggers the requirement to raise the railing height, design a compatible new railing.

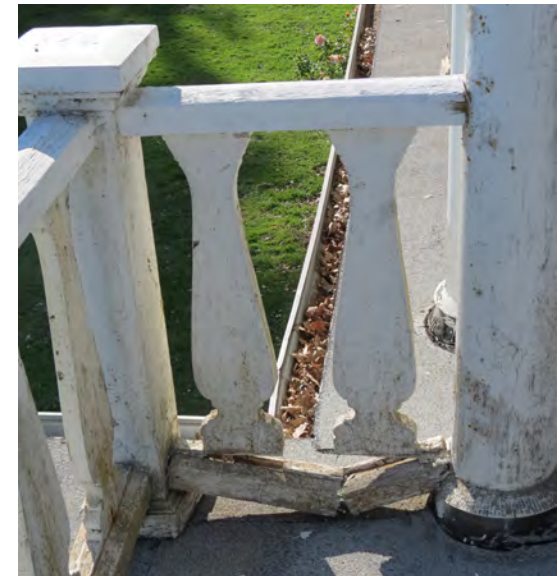
Figure 86. Broken piece of balcony railing.

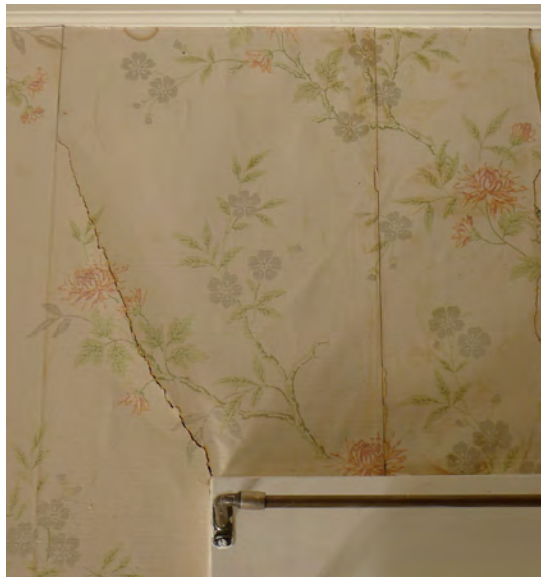
Figure 99. Cracked gypsum board and wallpaper in Room 109.

- Retain as much historic gypsum board as possible.
- Remove area of deteriorated gypsum board.

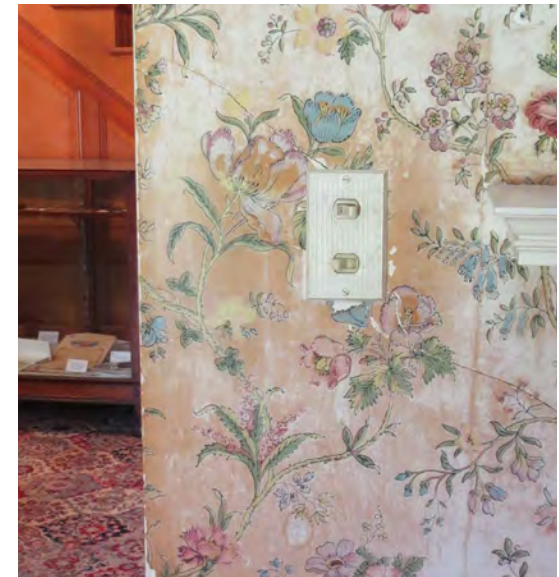
Figure 101. Stained wallpaper in Room 105.

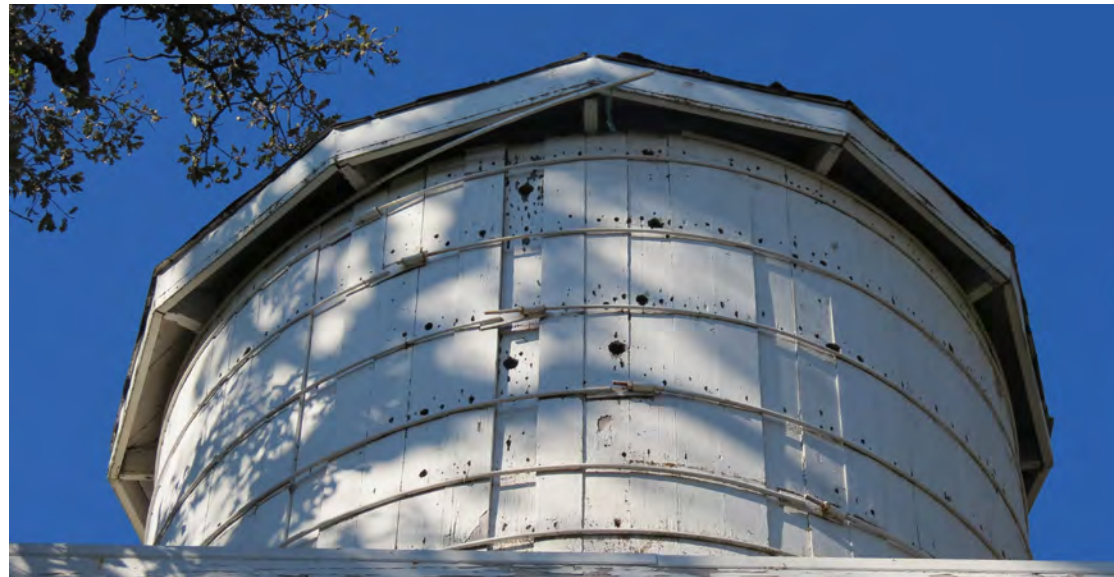
Figure 130. Woodpecker holes at tank boards.

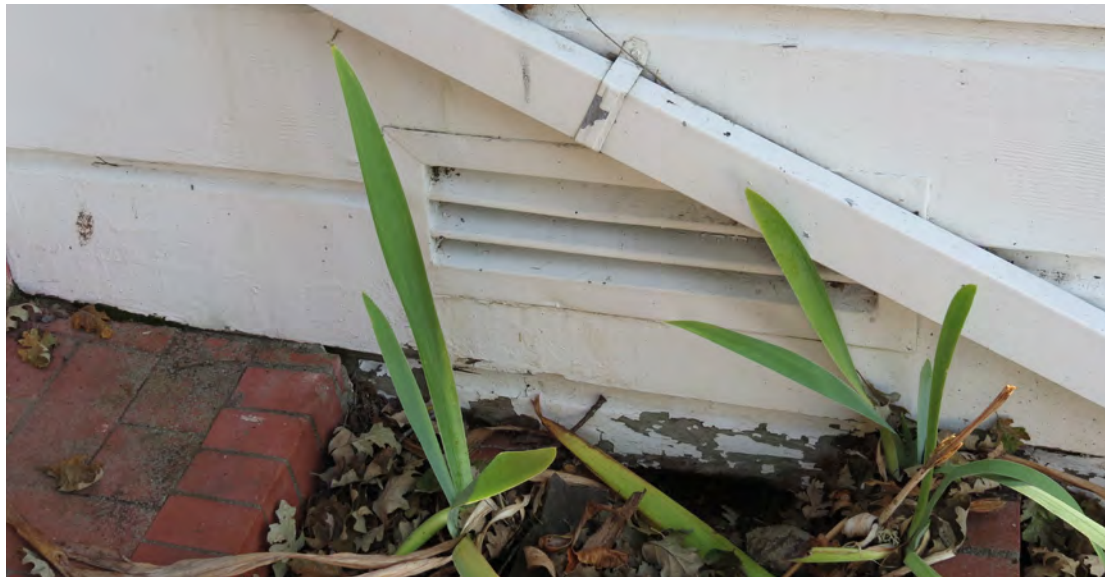
Figure 131. Damaged wood siding in contact with ground.

Recommendations: Perform a detailed cladding survey to identify conditions such as breaks,

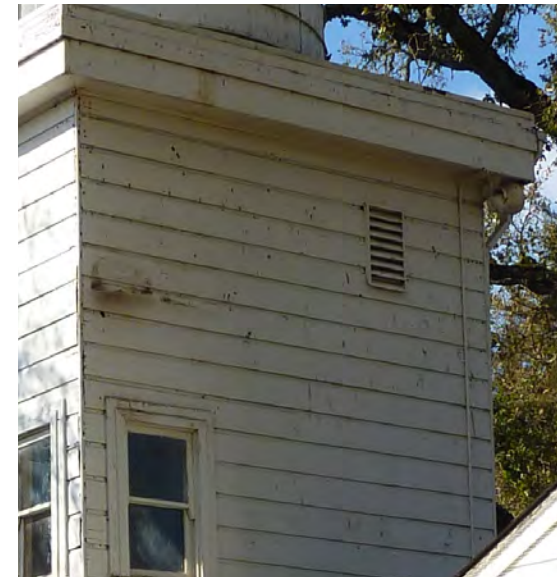
Figure 132. Damaged siding on northeast elevation of Tank House.

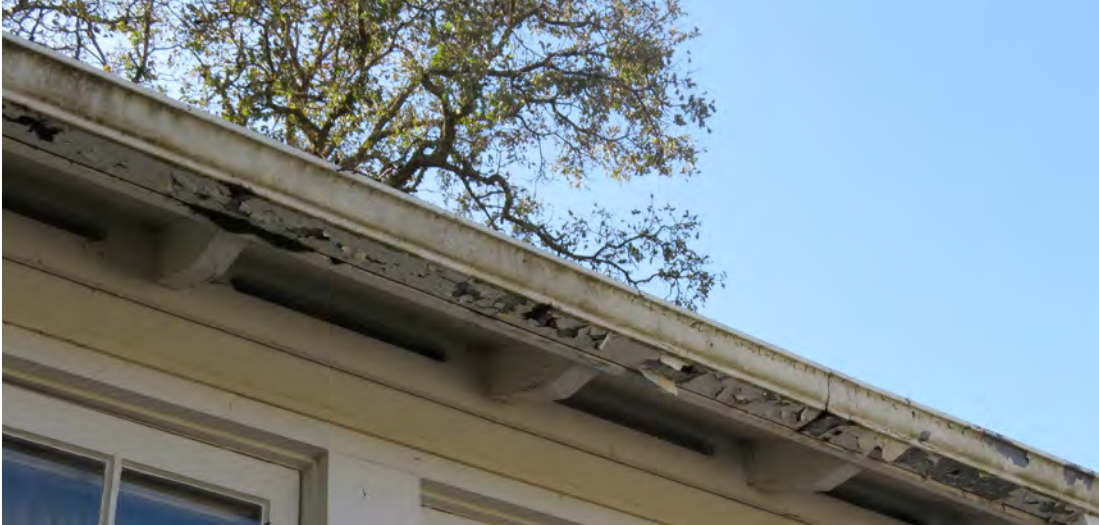
Figure 162. Gutter with severe paint loss on the underside.

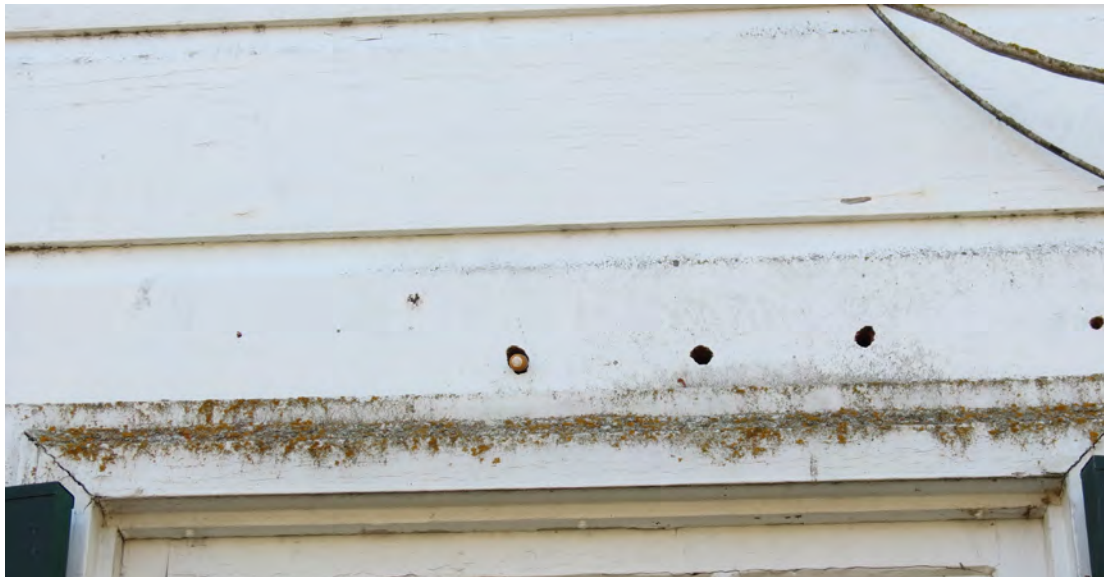
Figure 163. Woodpecker damage to wood siding.

Recommendations: Perform a detailed cladding survey to identify conditions such as breaks, cracks, loose or missing boards, woodpecker and insect damage, and biological growth. If structural repairs require removal of this material, it should be carefully salvaged, catalogued, and

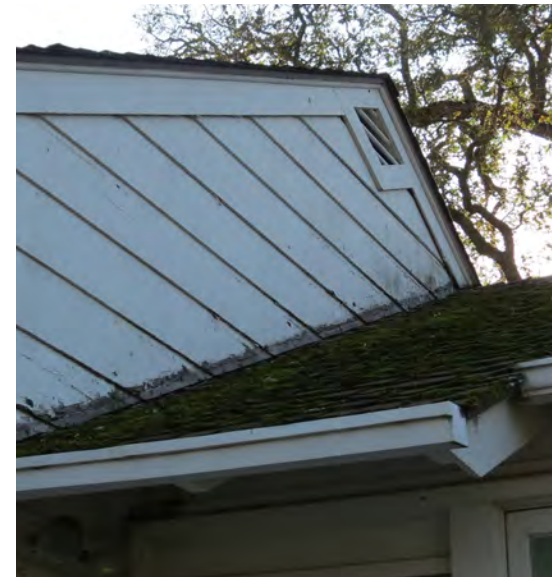
Figure 164. Paint loss and wood deterioration where north addition roof meets siding.

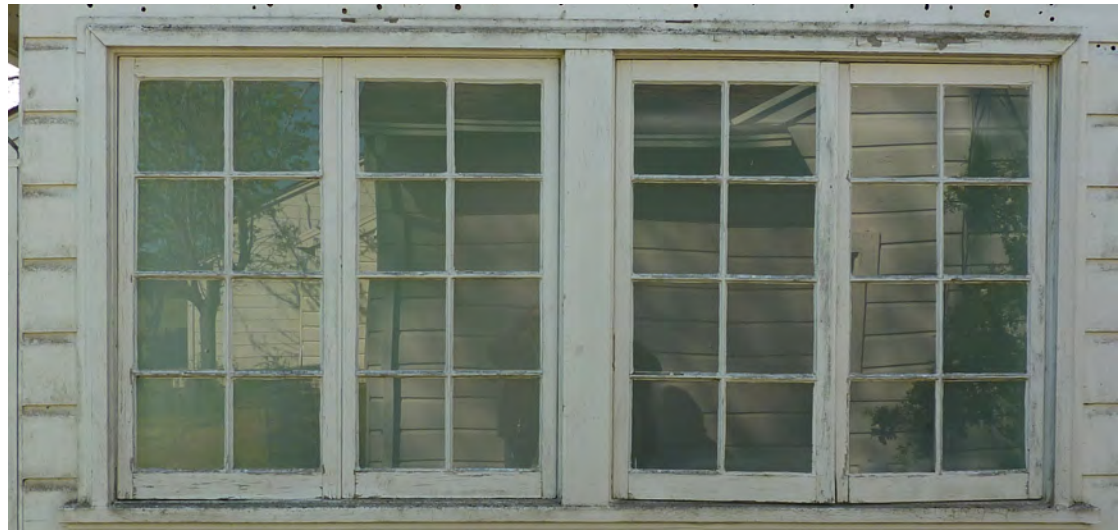
Figure 168. Wood casement windows with paint loss and biological growth.

- Remove dirt and debris.
- Replace any broken or deteriorated trim pieces in-kind. Pre-treat with wood preservative and back-prime all surfaces prior to installation.

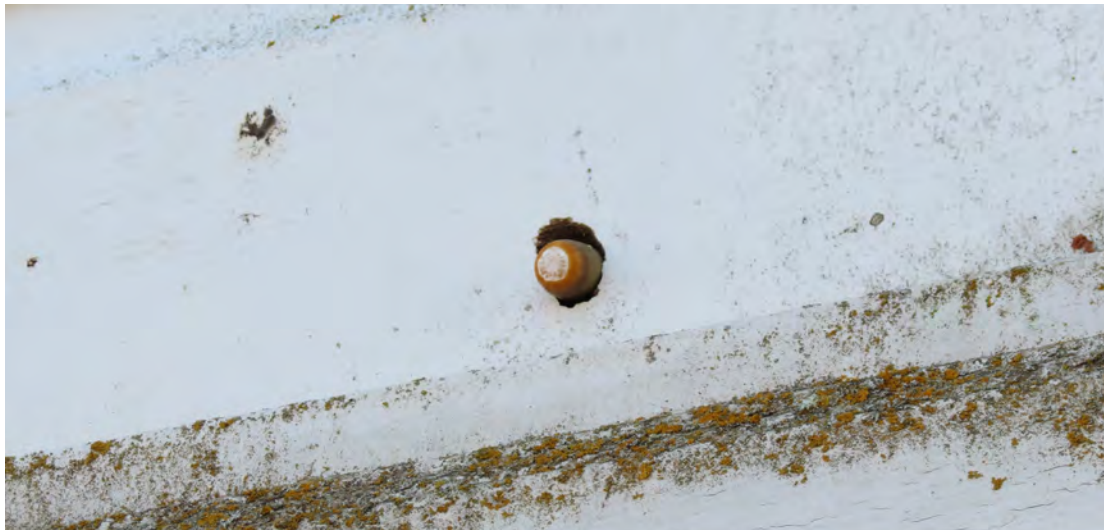
Figure 175. Biological growth and woodpecker damage in siding.

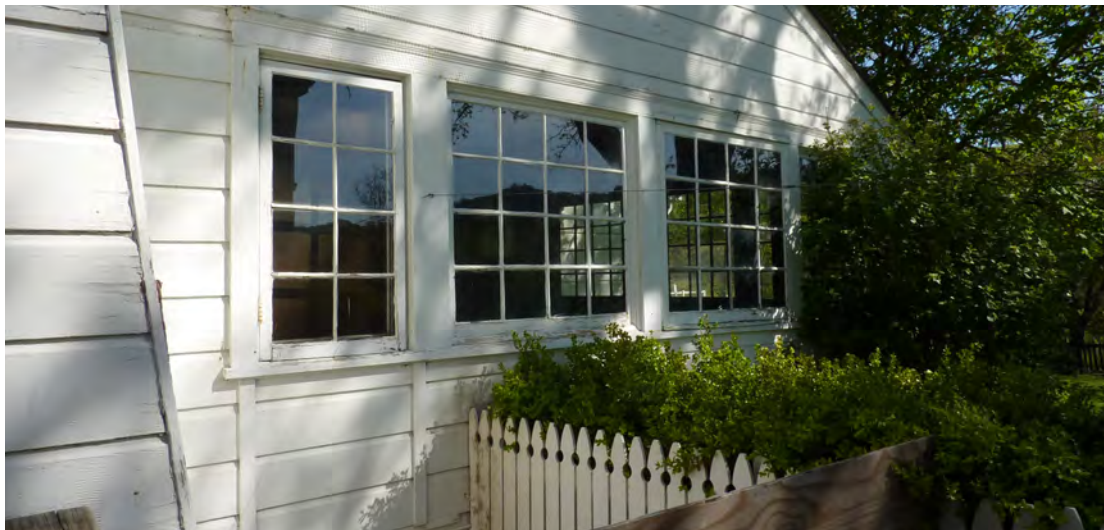
Figure 176. Vegetation against southeast elevation.

Recommendations: The Cook House needs to be completely re-painted. In its current state the deteriorating paint finish is only beginning to cause substrate breakdown. Paint is designed to be a sacrificial protective coating, and is necessary to prolong the life of the wood cladding. Should this work be deferred for long, substrate deterioration will accelerate, and the repairs will be correspondingly more extensive.

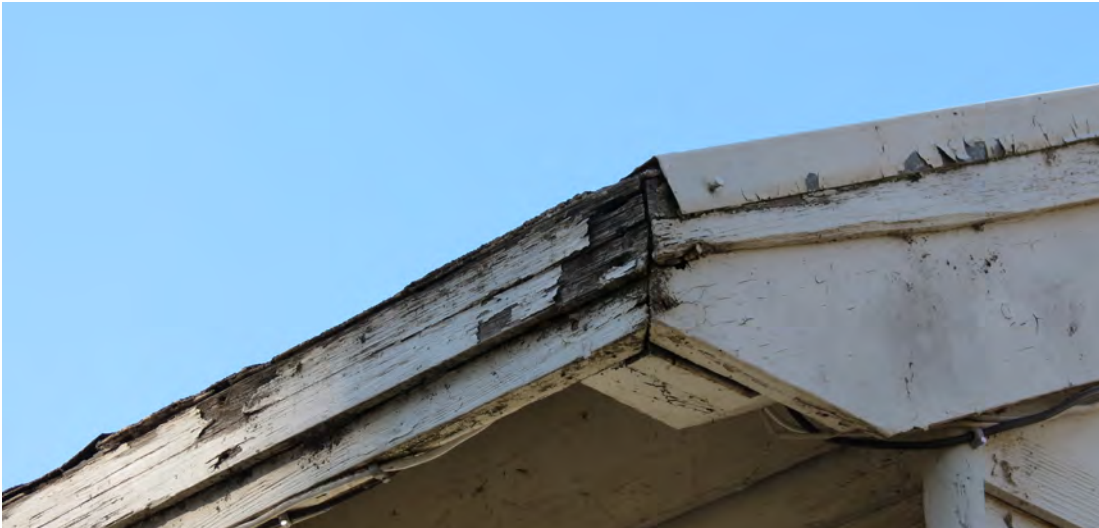
Figure 212. Roof eave with paint loss on wood and flashing and wood deterioration.

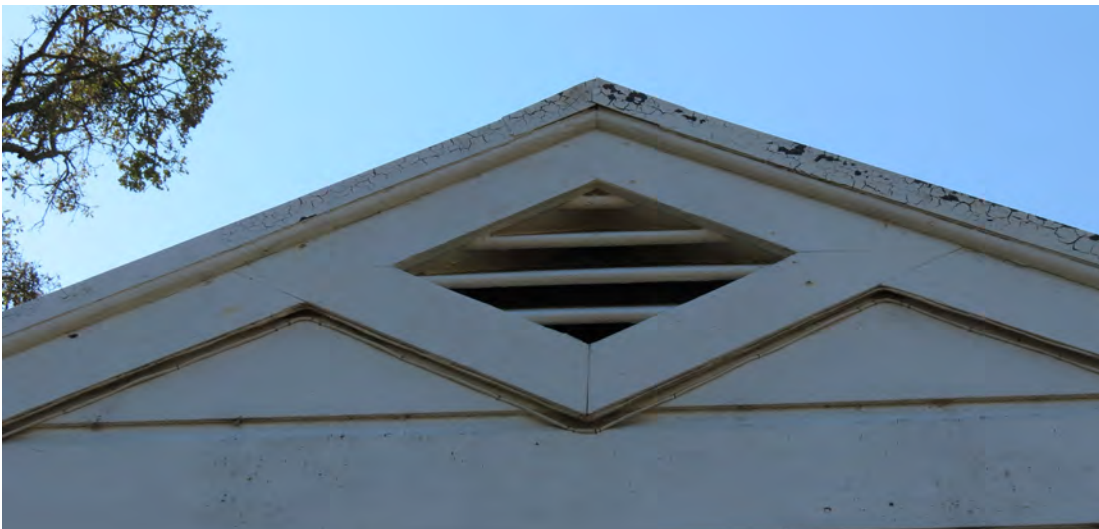
Figure 213. Attic vent and roof flashing with peeling paint.

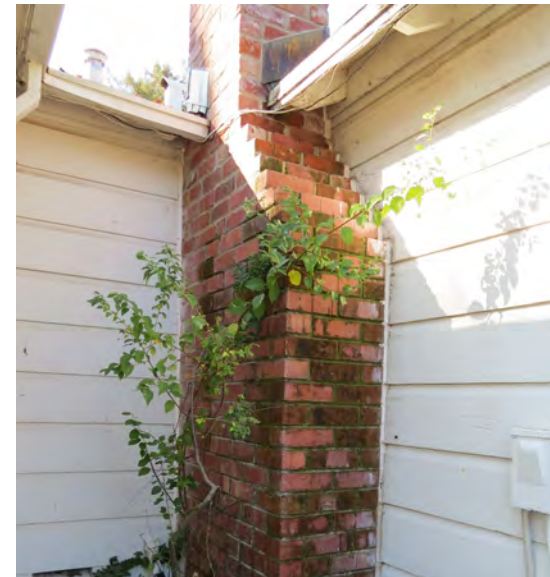
Figure 216. Biological growth and vegetation on chimney at 1937 addition.

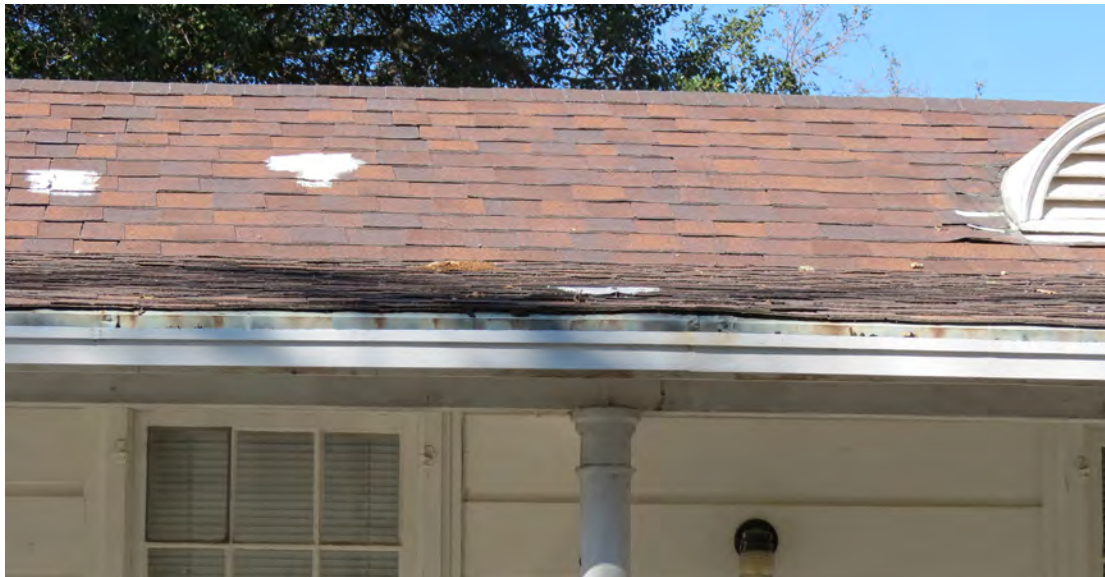
and contributing to moisture problems on the exterior envelope and on the interior of the building. Paint is peeling from the aluminum gutters, with heavy paint loss on the underside of the gutters. A buildup of leaves in areas of the gutters is causing water to spill out onto wood members. In some areas the gutters are sagging and not properly attached to the building. Several downspouts are detached and leaking, contributing to the staining and biological growth on the wood siding and eaves. Flashing at gutters is severely rusted (figure 217). Poor site drainage has caused the shiplap siding closest to deteriorate.

Figure 217. Damaged gutter and rusted flashing.

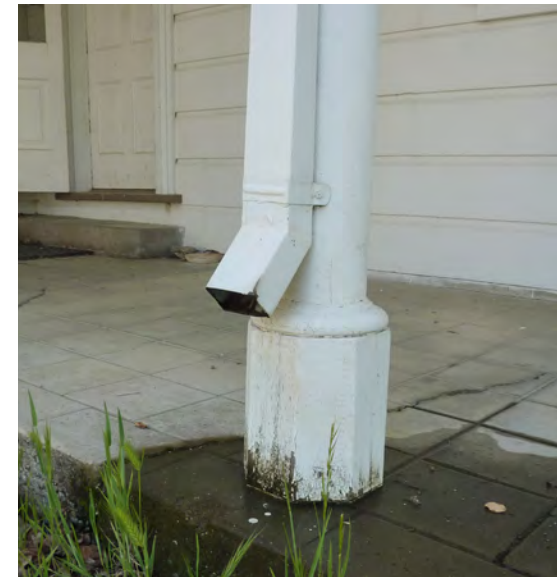
Figure 218. Downspout at base of wood column.

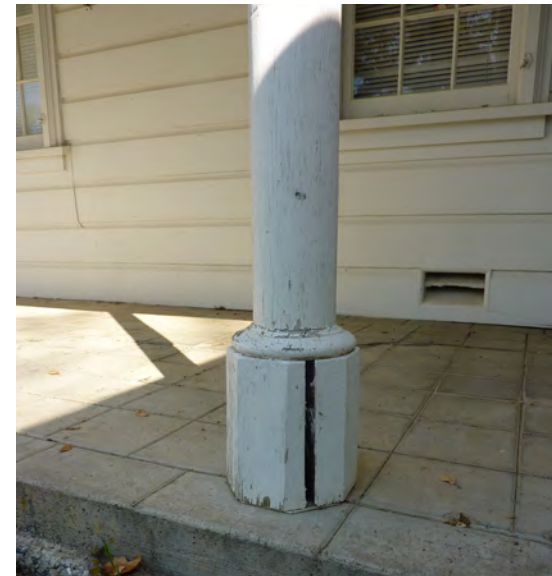
Figure 228. Wood column with damaged base.

- Survey and examine in detail the existing condition of all wood columns and posts.
- Remove all dirt and debris.
- Remove paint to obtain clean surface where repairs are required.
- Patch and repair deteriorated wood with wood Dutchman patches or an epoxy consolidant or compound appropriate for use on soft wood.
- Where the severity of deterioration precludes

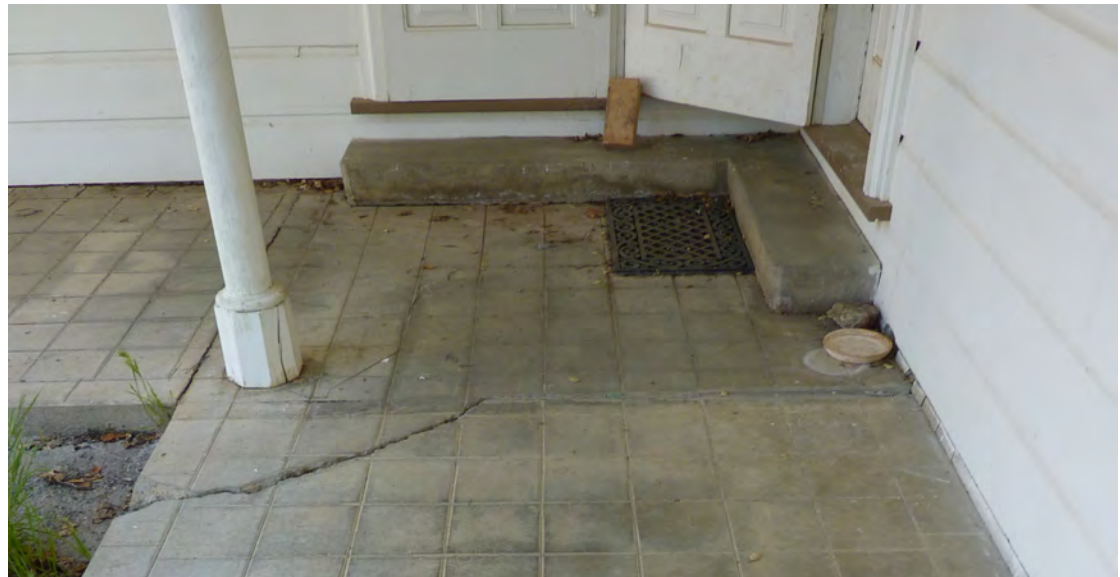
Figure 230. Stamped concrete porch with settlement cracks.

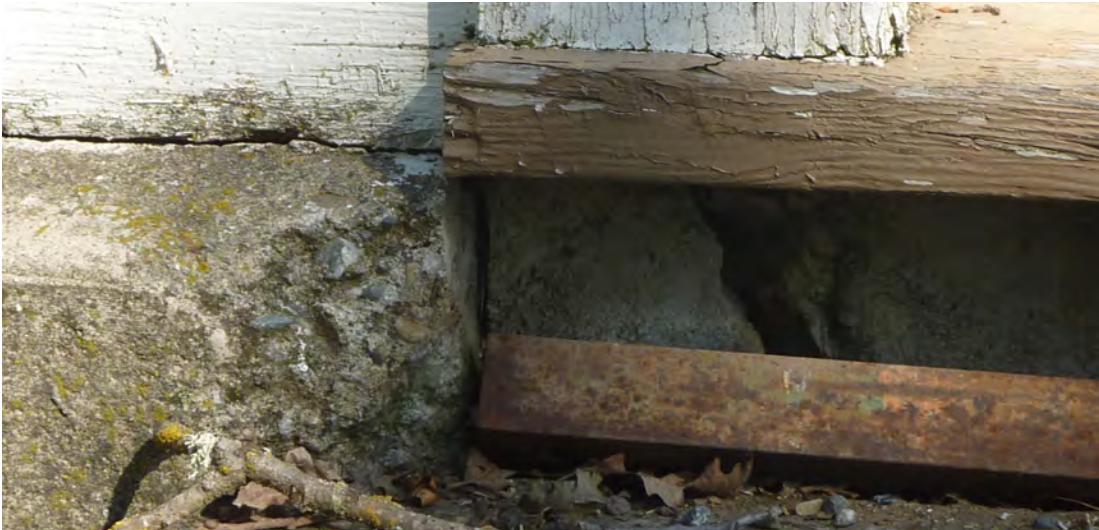
Figure 231. Deteriorating concrete foundation at entry to Room 105 - Wood shed.

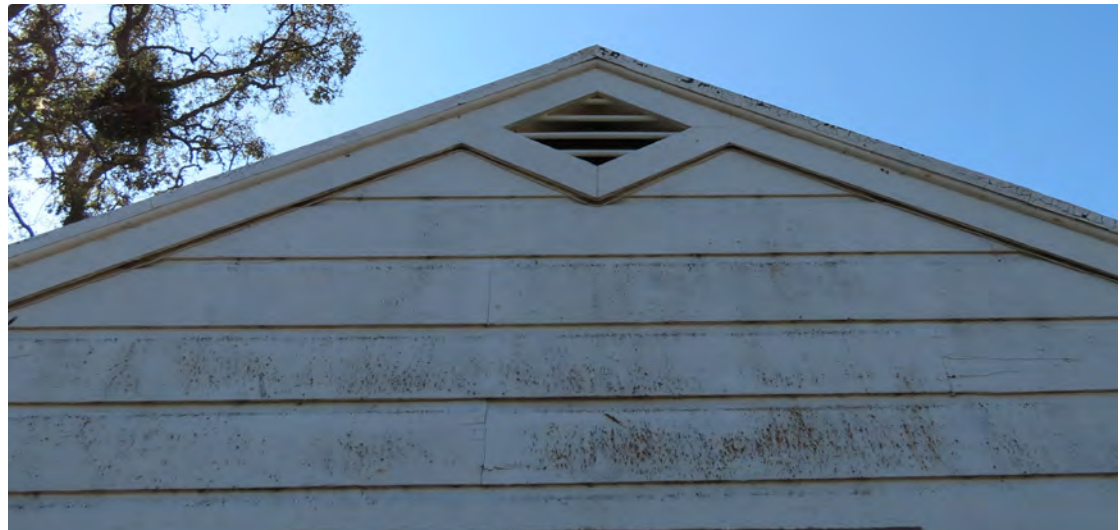
Figure 234. Biological growth staining on wood siding.

Description / Condition: The northwest elevation and roof slopes are heavily blanketed in biological growth including algae, lichen and fungi (figures 233 & 234) . Various types of fungi are present, evident as orange, green and black stain-

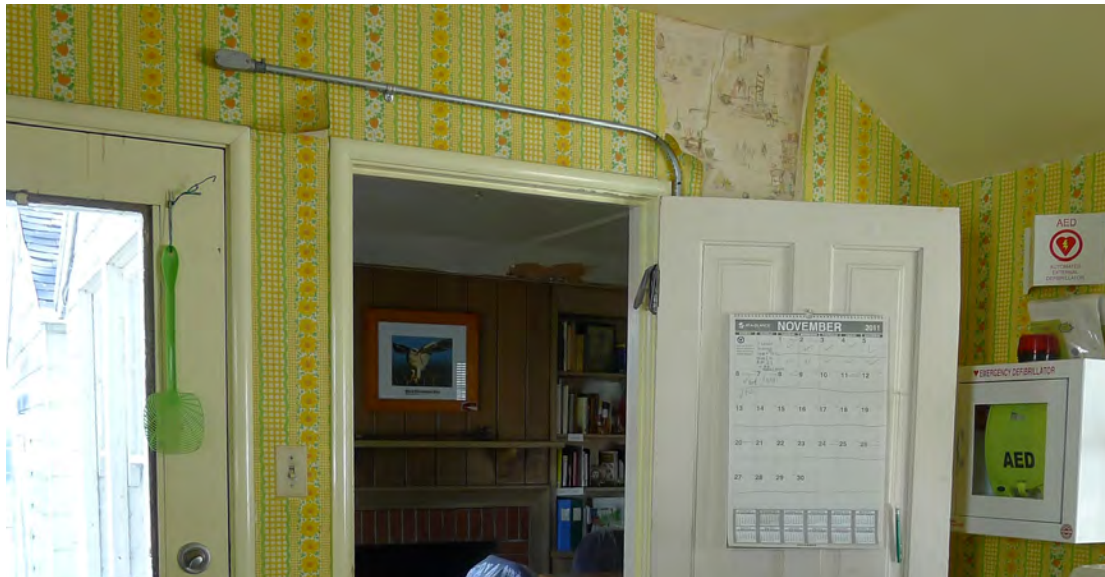
Figure 244. Wallpaper peeling in Room 102 - Kitchen.

- Retain as much historic gypsum board as possible.
- Repair hairline cracks in sound, adhered, gypsum board with a compatible commercial

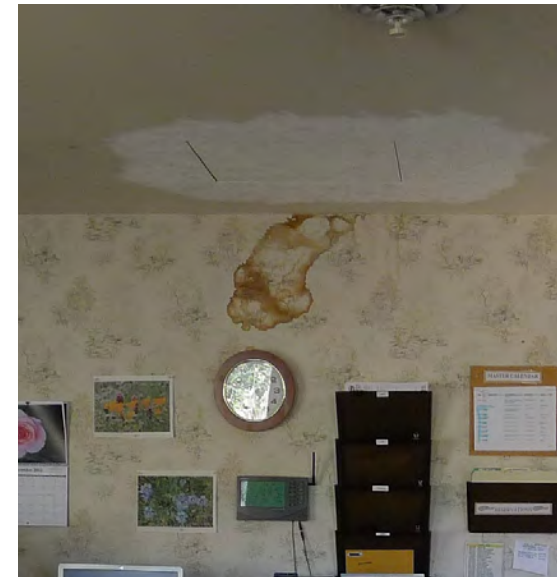
Figure 245. Water damage in Room 101.

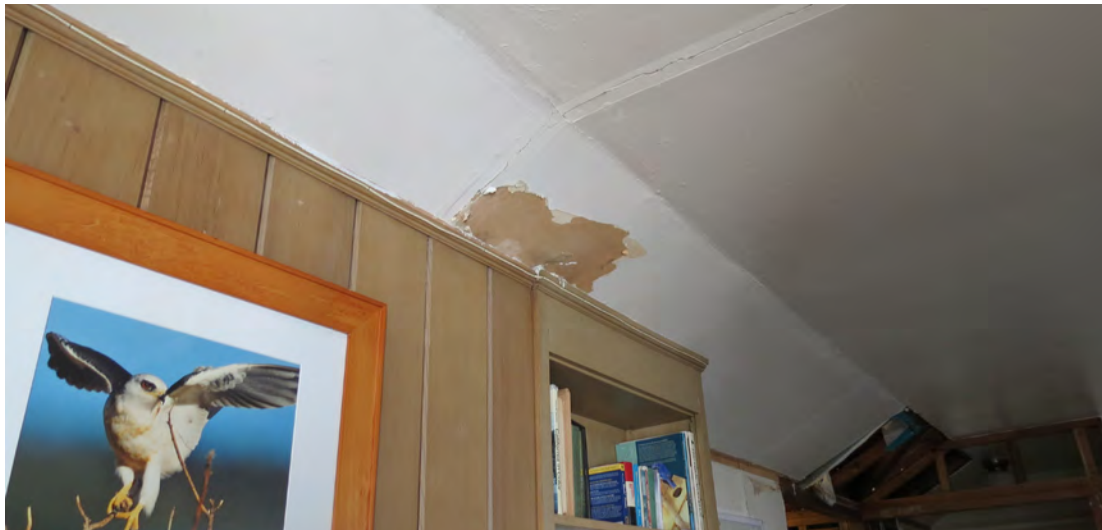
Figure 246. Ceiling damage in Room 103.

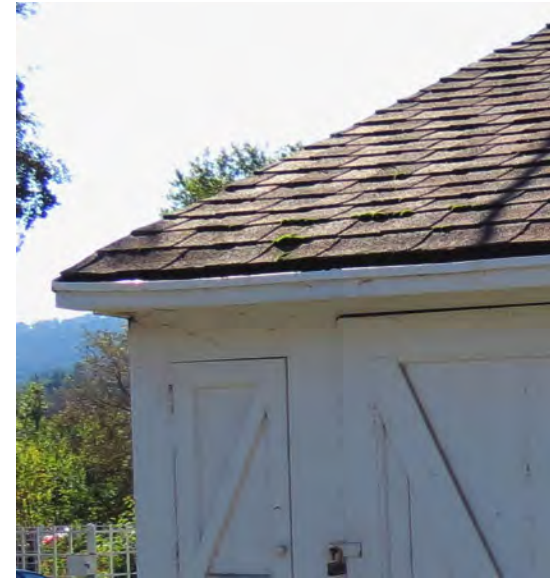
near the base where the siding touches the soil, a condition which is causing the wood and the paint to deteriorate faster. One of the garage door openings was infilled with shiplap siding and a window. Door and window trim is weathered, with peeling paint and separation between joints. This is most likely caused by moisture sitting on these wood surfaces for long periods of time, and on some elevations the weathering is from exposure to the sun. Doors and windows are generally weathered on the exterior and display moderate wood deterioration. The gutters have paint loss and, where not installed properly, the wood fascia is deteriorating. The composition roof shingles show biological growth on the surface and under

Figure 275. Biological growth on roof shingles.

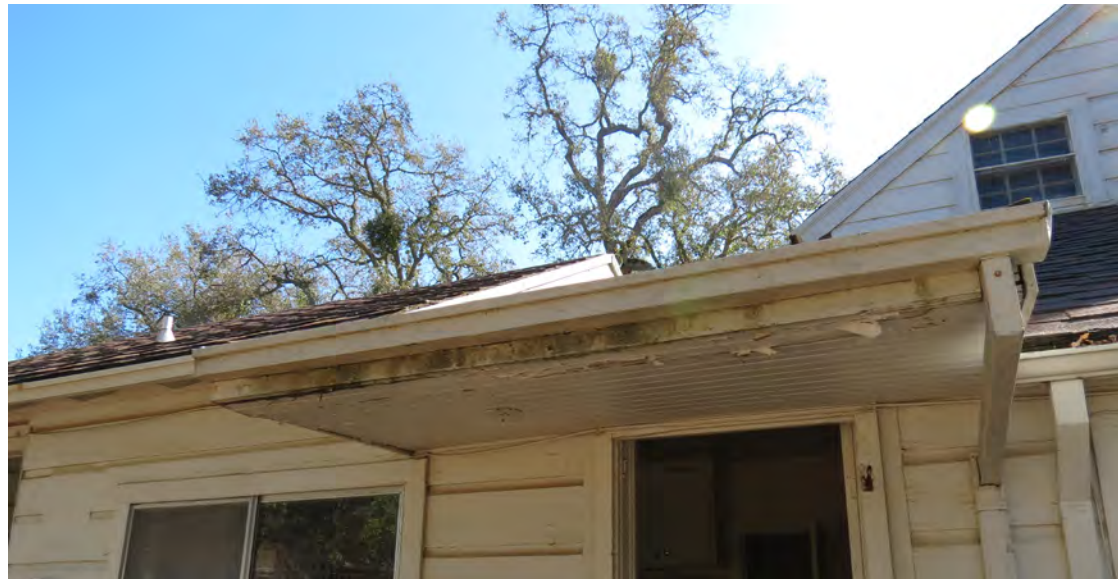
On the northwest side of the structure a large overhang shelters the door. This wood roof projection is severely deteriorating. The paint is peeling and mold grows on the surface. The bead board on the underside has extensive paint loss and water damage (figure 277). Also, see the next, related section on drainage.

Figure 277. Wood roof projection, Northwest Elevation.

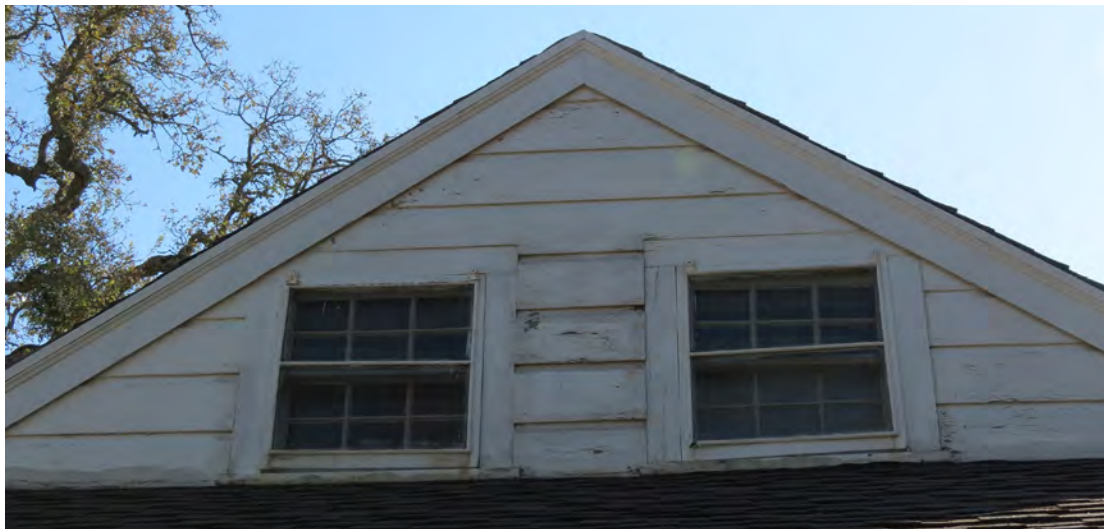
Condition: The trim around the windows and doors are in fair condition (figures 286 & 287). Paint is peeling on many of the trim elements. Nails are rusting, staining the painted surfaces. Separation is visible between joints. Wood deterioration and biological growth occurs at horizontal surfaces, including the sills. Poorly installed flashing above the trim is trapping water, causing wood and paint deterioration. Deterioration of wood and paint on door trim is worse closer to the ground. Address the wood trim repairs as follows:
Recommendations: Perform a detailed wood trim survey to identify conditions such as breaks,

Figure 286. Windows with trim deterioration.

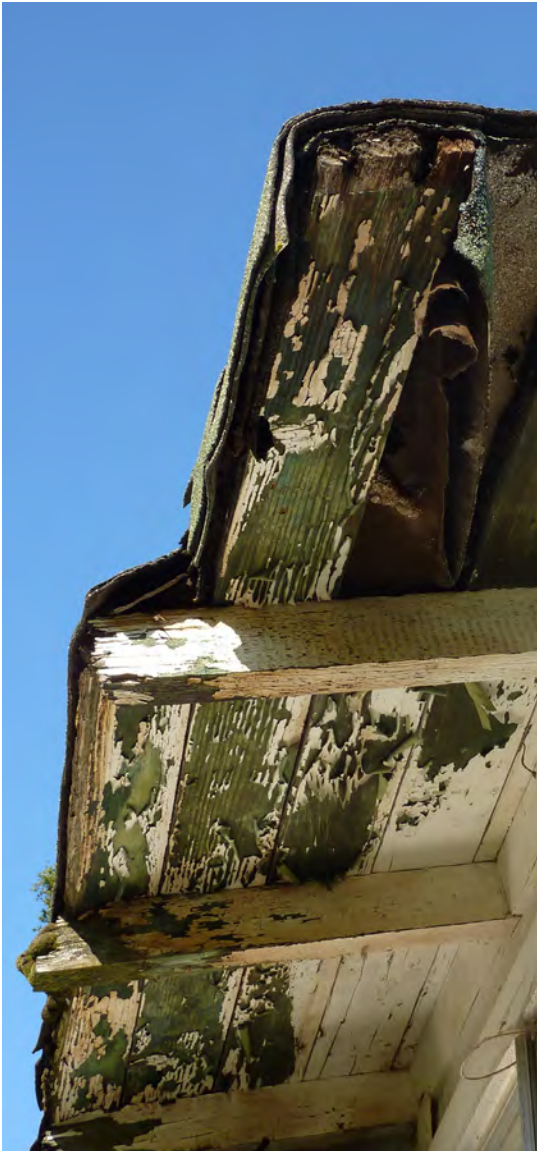
Figure 324. Deteriorated rafters and sheathing.

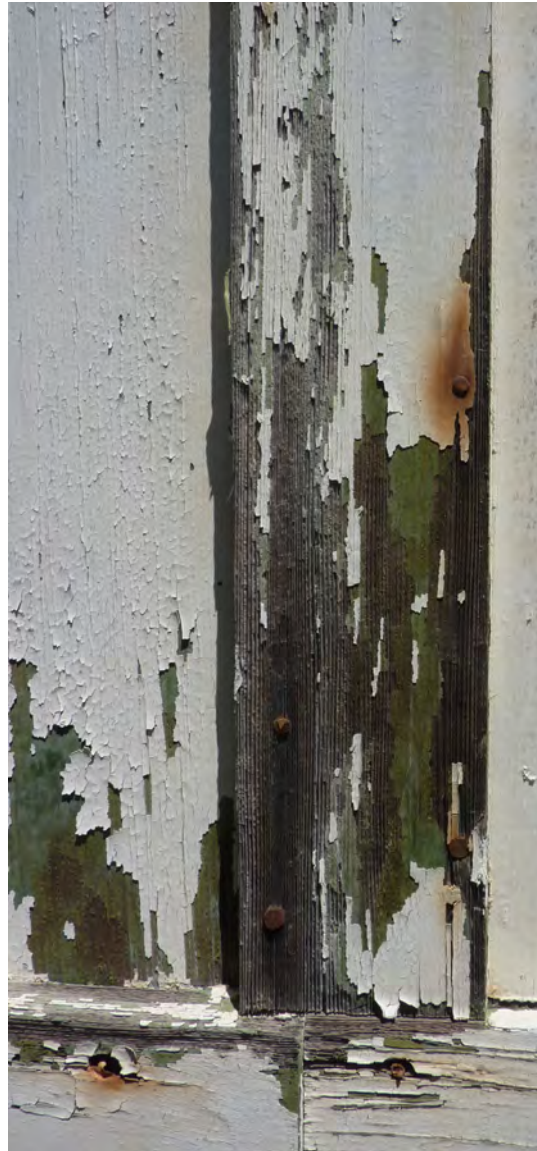
Figure 333. Peeling paint.
