HISTORIC STRUCTURES REPORT

GRANT RANCH HOUSE COMPLEX

JOSEPH D. GRANT COUNTY PARK

Final Report
November 7, 2012

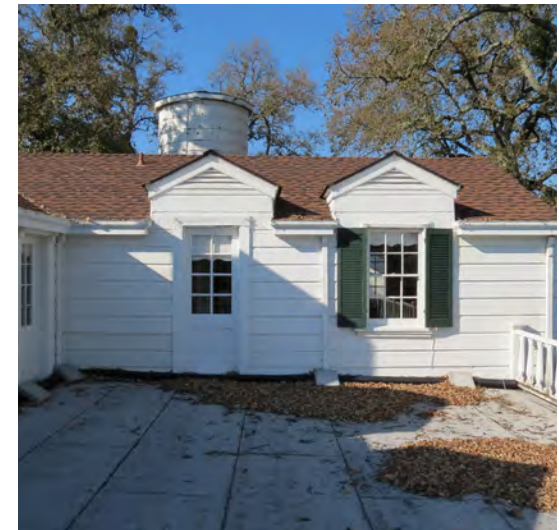
Figure 63. Roll roofing balcony floor.

Description: Asphalt composition shingles cover the roof and the roof dormers. Roll roofing covers the balcony floor (figure 63).

Condition: The composition shingles have areas with heavy biological growth. Areas around gutters and in the shade are particularly bad. Water damage is evident at all of the cornices. Damage is so great that wood elements have fallen from the building in some locations and joint locations are separating creating large holes for the water to run out of. The siding on the dormers is deteriorating near where dormers meet the roof (figure 64). No flashing is visible at these locations. The roll roof on the balcony is curling at seams and deteriorating near the edges. Also, see the related section on drainage.

Recommendations: A roof is a highly vulnerable element of any structure. It is also the first line of defense against water intrusion. Asphalt shingles and roll roofing have a finite life span and these assemblies will inevitably fail as a result of normal weather exposure and wear. The following are general recommendations:

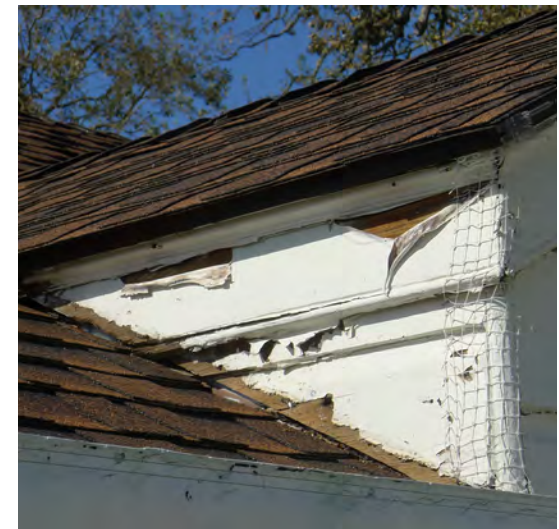
Figure 64. Deteriorating siding on dormers.

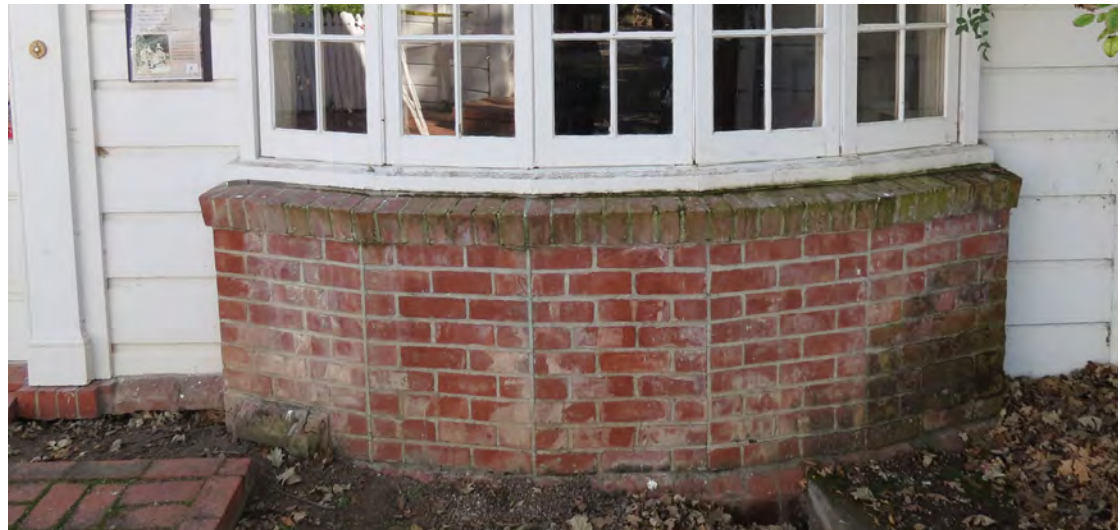
Figure 65. Brick cladding at Room 103 bow window.

Condition: All chimneys have been recently rebuilt and stabilized and all are in good condition. Leaves and other debris have built-up between the chimney stacks and the pitched roof planes, which trap moisture and cause the composition to deteriorate more rapidly. The brick veneer on the northwest elevation is in fair condition with signs of water infiltration and biological growth on the surface.

Currently no repointing is necessary. There are currently no areas of missing brick, however many of the bricks near the soil have clear evidence water infiltration and biological growth. Implement drainage measures and then repair brick masonry as follows:

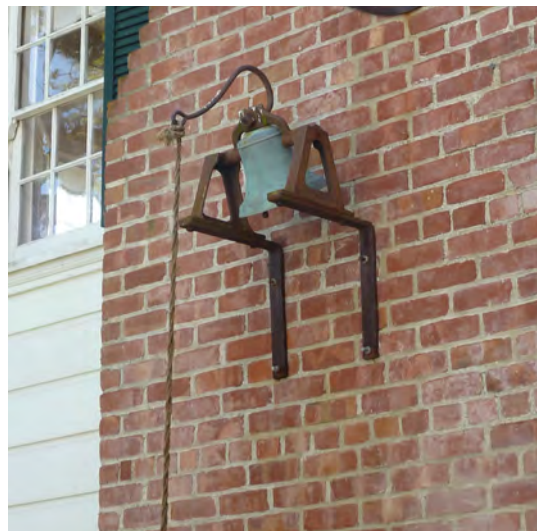
Description: Four chimneys are found at various places around the Main House. The brick chimney located near the entry door on the northwest elevation has a bell attached to the stack. Metal brackets hold the bell up and a metal decorative tie is attached to the brick above the bell (figure 66). The other brick chimney is on the northeast elevation off the enclosed porch (figure 67). This structure also has two interior brick chimney stacks. Installed near the entry door, on the northwest elevation, is a small section of brick veneer (figure 65). Additionally brick veneer also lines the concrete foundation on the northwest elevation.

Figure 66. Brick chimney with attached bell.

Recommendations: Remove debris that builds up behind the chimney stacks. This will help extend the life of the roof. Because the main cause of brick masonry deterioration is water intrusion, the presence of water against the walls must be removed to the greatest extent possible. The first step in this process is to implement the recommendations listed under the drainage discussion.

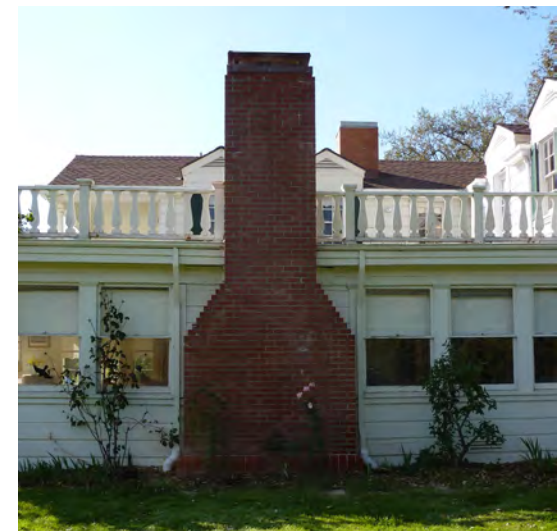
Figure 67. Brick chimney adjacent to Room 104 - Sunroom.

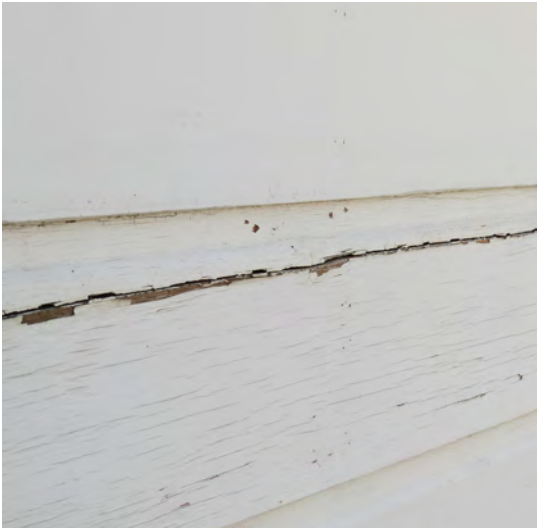
Figure 72. Longitudinal split in siding.

Recommendations: Perform a detailed cladding survey to identify conditions such as breaks, cracks, loose or missing boards, insect and woodpecker damage, and biological growth. If structural repairs require removal of this material, it should be carefully salvaged, catalogued, and reinstalled at its original location. General recommendations are as follows:

- Remove dirt, debris and miscellaneous non-functional attachments.
- Replace any broken or deteriorated boards in-kind. Pre-treat with wood preservative and back-prime all surfaces prior to installation.
- Patch and repair wood damage from woodpeckers with epoxy consolidant or repair compound formulated for wood.

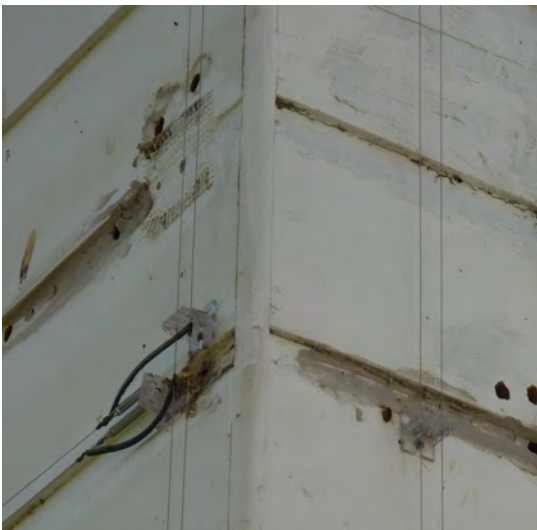
Figure 73. Woodpecker damage to siding.

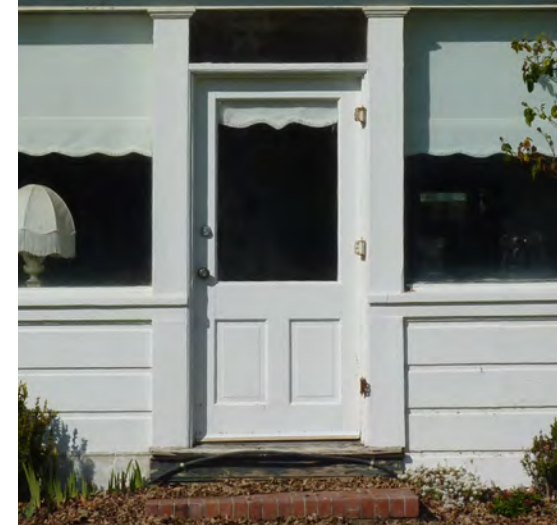
Figure 75. Single lite over two-panel door at sunroom.

Description: A variety of wood doors are used throughout the exterior of the building and include six-panel with diamond multi-lite sidelights (figure 74), two-panel and three-panel doors with glazing in the upper panels (figure 75). Several 12-lite over 2-panel doors allow access out onto the second floor balcony. Screen doors are also found at a few of the door openings.

Condition: The doors and screen doors are in fair condition, condition varies depending on weather exposure, type of door, and state of repair. Most of the doors have been altered slightly by the removal of original locks which were replaced with modern latching and locking mechanisms. Many of the thresholds are worn and weathered.

- Perform a detailed survey/inspection of all doors to identify specific repair locations.
- Remove all dirt and debris from surface.
- Remove finish if necessary to perform repairs.
- Remove existing glazing compound where it has failed.
- Repair splits and separations with waterproof glue as required.
- Consolidate deteriorated wood with epoxy or perform Dutchman repairs. Replace extensively deteriorated components in-kind.
- Install weather-stripping.
- Install new glazing compound.
- Recondition extant original hardware. Install new hardware, where missing, to match original, with secondary deadbolt hardware to provide security.
- Ensure the smooth operation of all doors.
- Finish doors to appropriate interpretive period.
- Inspect doors regularly for deficiencies of finish and operation.

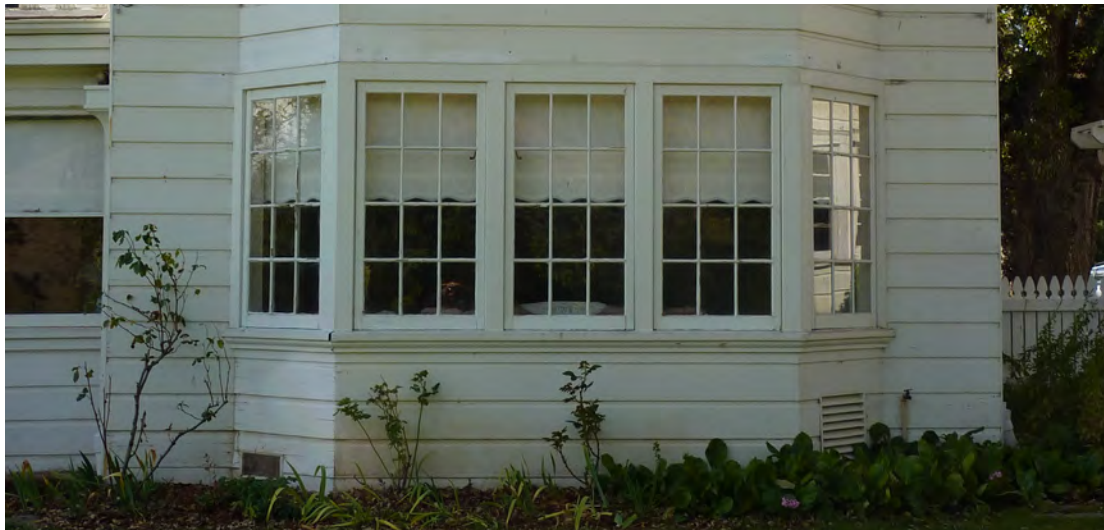
Figure 76. Multi-lite wood casement windows.

Description: A variety of multi-lite double-hung and casement wood windows are found throughout the exterior of the building. The casement windows are found at the bay and bowed windows (figure 76). At the enclosed porches the windows are a combination of large fixed win-

Condition: The windows are in fair to poor condition. The exterior paint is deteriorated at many of the windows. Joint separation between the wood members occurs at many of the windows. Much of the glazing compound is dried, cracked or missing. Several of the windows have broken panes. In addition to lead in the existing paint, asbestos may be found in the glazing compound. Windows and sills on all sides of the building have black biological growth stains. Some of the windows are not aligned properly in their frame causing large gaps and allowing the elements, as well as pests to enter the building (figure 77). It appears that much of the original hardware is intact, but the actual extent should be determined by a survey. Several diamond panes of leaded glass that surround the entry door are broken.

- Survey and examine in detail the existing condition of all wood windows.
- Remove all dirt and debris.
- Remove paint to obtain clean surface where repairs are required.
- Remove existing glazing compound where it has failed. As the existing compound contains asbestos, follow legal means for handling, removal, and disposal of contaminated material.
- The broken diamond panes of leaded glass need to be replaced in-kind.

- Consolidate, repair or replace deteriorated wood elements in-kind, where necessary.
- Restore window to proper operation.
- Install new hardware, where missing, to match original.
- Install new glazing, where cracked or missing.
- Install new glazing compound.
- Install new glazing, where cracked or missing.
- Prepare wood surfaces prime and paint to match historic finishes.
- Install new weather stripping.

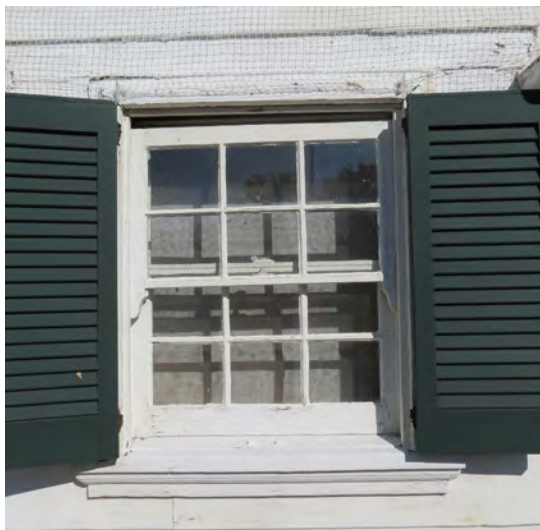
Figure 77. Double hung wood window out of plumb.

Description: Painted wood louvered shutters flank many of the windows (figure 77).

Condition: The louvered shutters are in good condition.

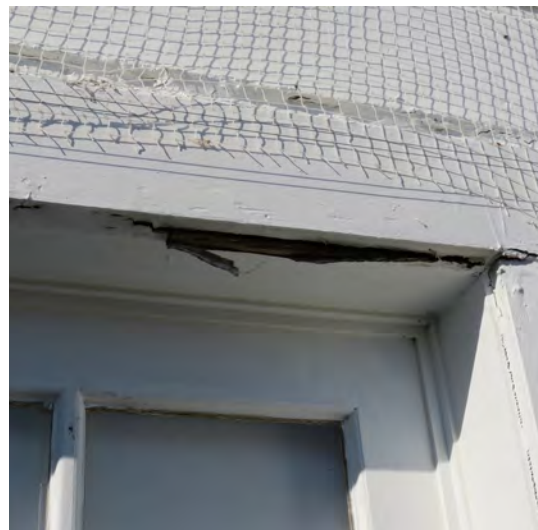
Figure 78. Damaged wood window trim.

doors under the balcony are in good condition, while trim around the more exposed openings are weathered (figure 78). The window sills that are exposed directly to the elements are extremely weathered. Biological growth is primarily on the horizontal trim members where water is allowed to stand. The pilasters at the main entry are deteriorated at the bottom where the wood is closest to the brick. Because the wood has deteriorated so much there is a large gap between the brick and the wood pilaster allowing water to enter this space. The wood pilasters at the enclosed porch have peeling paint and wood deterioration where water sits on the horizontal surfaces. The wood fascia and rake boards have peeling paint and in some locations large areas of wood are exposed to the elements.

Recommendations: Perform a detailed wood trim survey to identify conditions such as breaks, cracks, loose or missing, insect and woodpecker damage, and biological growth. If structural repairs require removal of this material, it should be carefully salvaged, catalogued, and reinstalled at its original location. General recommendations are as follows:

- Remove dirt and debris.
- Replace any broken or deteriorated trim pieces in-kind. Pre-treat with wood preservative and back-prime all surfaces prior to installation.

- Patch and repair wood damage from woodpeckers with epoxy consolidant or repair compound formulated for wood.
- Reattach any loose elements with stainless steel fasteners.
- Treat with a fungicide if required, then prime and paint. Include fungicide in the paint to discourage future biological growth.
- Repaint using historically appropriate paint colors.

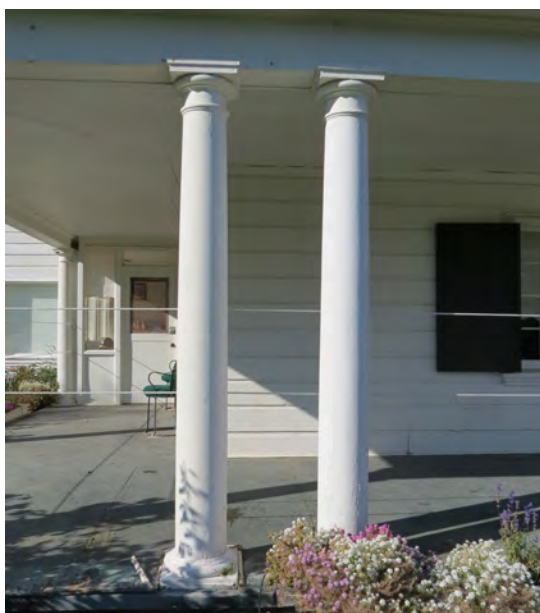
Figure 79. Pair of columns supporting second floor balcony.

mal detail, line the porch and support the roof projection at the balcony (figure 79). The circumference of the columns at the porch is greater than those supporting the roof projection.

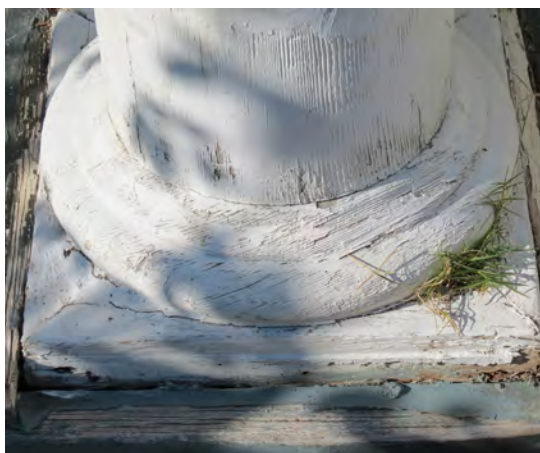
Figure 80. Paint loss at base of wood column.

Condition: Paint loss at the bases of the columns is severe (figure 80). The loss of paint has led to wood deterioration. Biological growth is prevalent where water is able to stand for long periods of time on horizontal surfaces.

Recommendations: For repairs to wood columns:

- Survey and examine in detail the existing condition of all wood columns.
- Remove all dirt and debris.
- Remove paint to obtain clean surface where repairs are required.
- Consolidate, repair or replace deteriorated wood elements in-kind, where necessary.
- Where the severity of deterioration precludes repair, replace the columns and posts with in-kind materials, and the original design profile.
- Prepare wood surfaces prime and paint to match historic finish. For new posts, back prime the end grain bearing points before installing.

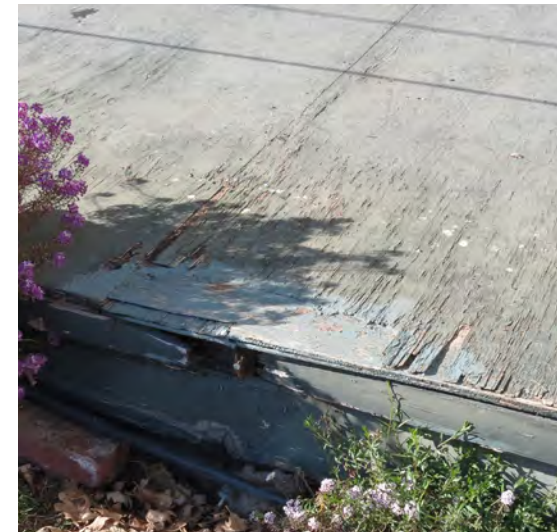
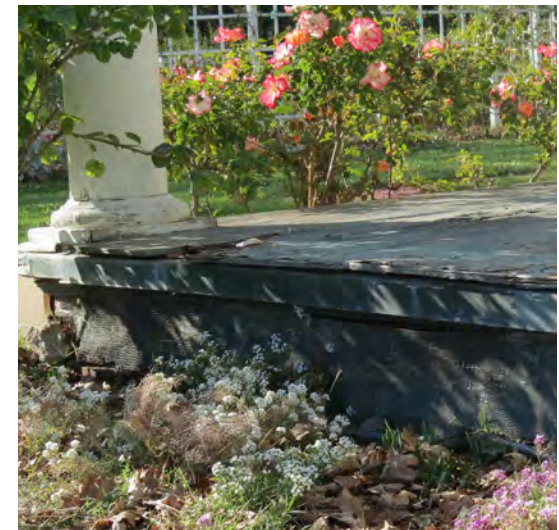
Condition: The plywood porch floor and wood columns are deteriorating due to moisture intrusion (figures 81 & 82). The paint on the plywood is severely worn, exposing the wood surface, causing the wood to deteriorate enough to cause

Figure 81. Deteriorating edge of porch.

Figure 82. Deteriorating edge of porch.

holes through the surface. Paint is peeling from the bead board paneling.

Recommendations: The porch floor requires immediate treatment before the effects of water intrusion advance and cause further deterioration to the painted plywood. Follow the repair or replacement procedures as follows:

- Remove all plywood deck and 1 x 6 tongue and groove material. Replace with 1 x 6 tongue and groove deck boards.
- Paint the deck with an alkyd enamel coating designed for use on wood decks.
- Remove all dirt and debris from bead board paneling.
- Remove paint to obtain clean surface where

repairs are required.

- Replace any deteriorated bead board paneling at ceiling.
- Consolidate, repair or replace deteriorated wood elements in-kind, where necessary.
- Prepare wood surfaces prime and paint to match historic finish.

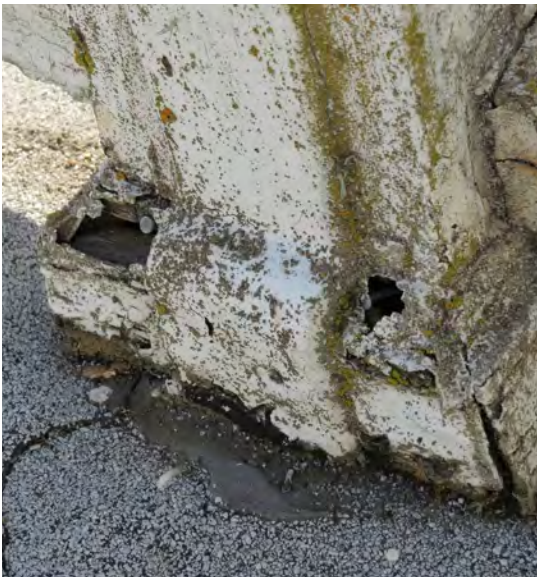
Figure 83. Deteriorating base of railing post.

Condition: The wood railing is severely deteriorated. Many of the wood members are broken, cracked detached or deteriorated (figures 83-86).

Recommendations: Areas of the railing that are severely damaged should be reconstructed.

- Survey the balcony railing, cap rail and balusters for cracked, missing, or deteriorated pieces. Determine the extent of replacement.
- Repair and replace deteriorated wood rail cap and baluster sections with wood Dutchman or epoxy consolidant and fill. Where deterioration is severe, replace with in-kind materials, and profiles. The current railing is less than 42", the code-mandated height for guardrails. If proposed work triggers the requirement to raise the railing height, design a compatible new railing.

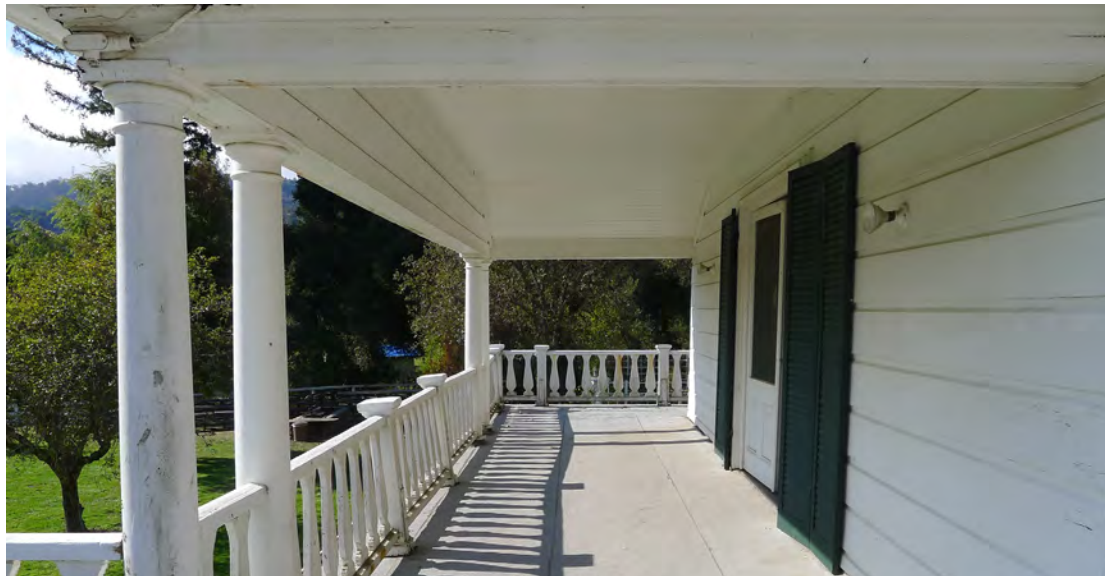
Figure 85. Second floor balcony beneath gable projection.

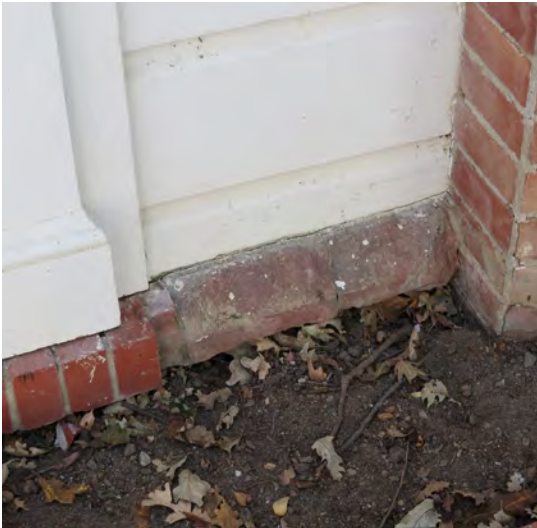
Figure 87. Small exposed section of brick clad foundation.

Description: Only a small section of the board formed concrete foundation is visible. Brick clads a section of the foundation near the entrance (figure 87).

Condition: The concrete foundation, where visible, is crumbling. Brick cladding is in fair condition.

Recommendations: See the structural section for detailed recommendations regarding the concrete foundation.

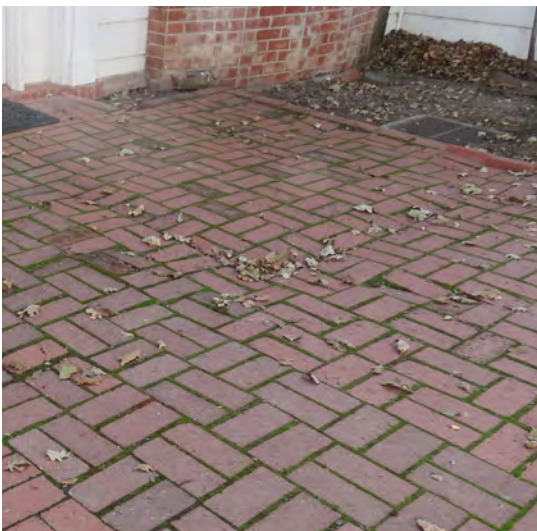
Description: Brick walkways appear to be very much in tact and without subsidence, suggesting that they were embedded in a compacted or concrete base. The patio bricks at the entry between the Main House entry door and Tank House were placed directly on the soil (figure 88). Historically the brick entry was on a raised concrete pad.

Condition: The entry patio bricks have settled into the soil, causing the surface to be uneven and potentially dangerous. Several bricks are cracked and a number of bricks display biological growth. Several bricks are dislodged or missing.

Figure 88. Uneven bricks at entry.

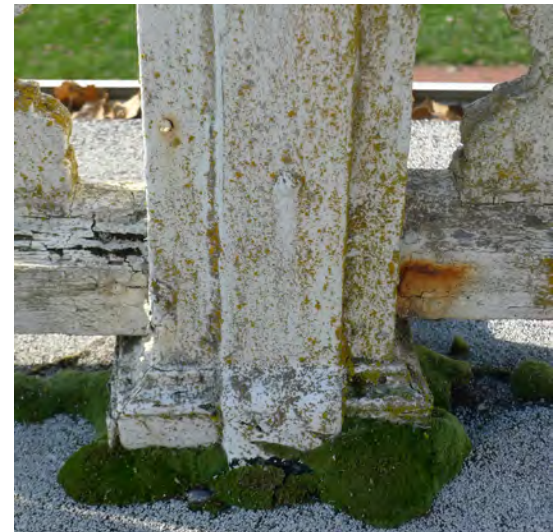
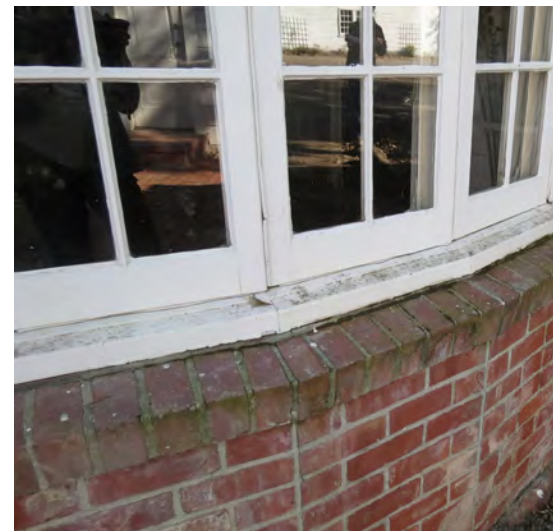
Description / Condition: Biological growth includes algae, lichen and fungi (figures 89 & 90). These problems are evident in the staining visible at the damp, shaded areas of the exterior. Various types of fungi are present, evident as orange, green and black staining. Biological organisms are not only unsightly but can, especially in the case of dry rot, cause serious damage. Treat biological growth as follows:

Figure 89. Heavy biological growth.

Figure 90. Biological growth on bricks and window sill.

Recommendations: Survey all exterior siding and woodwork, both to locate active infestations and

to identify and locate sources of moisture ingress.

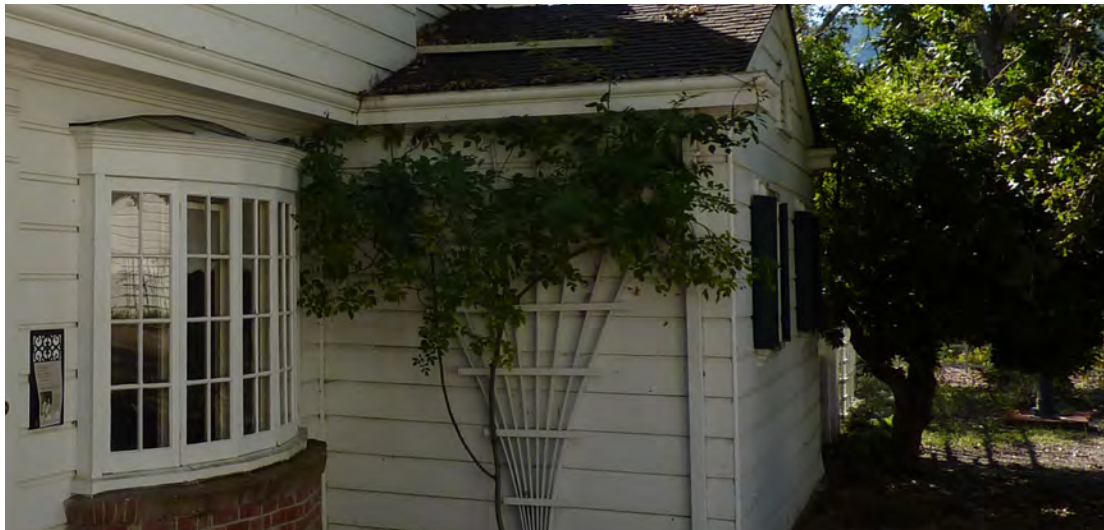
Figure 91. Trellis with climbing plant against Main House.

Description: Abundant landscaped vegetation historically existed on the site. Today, foundation plantings grow against the Main House on all sides with a tree in close proximity to the north-west elevation (figure 91). Several of the plantings are large bushes that have grown up against the side of the building. Several large branches

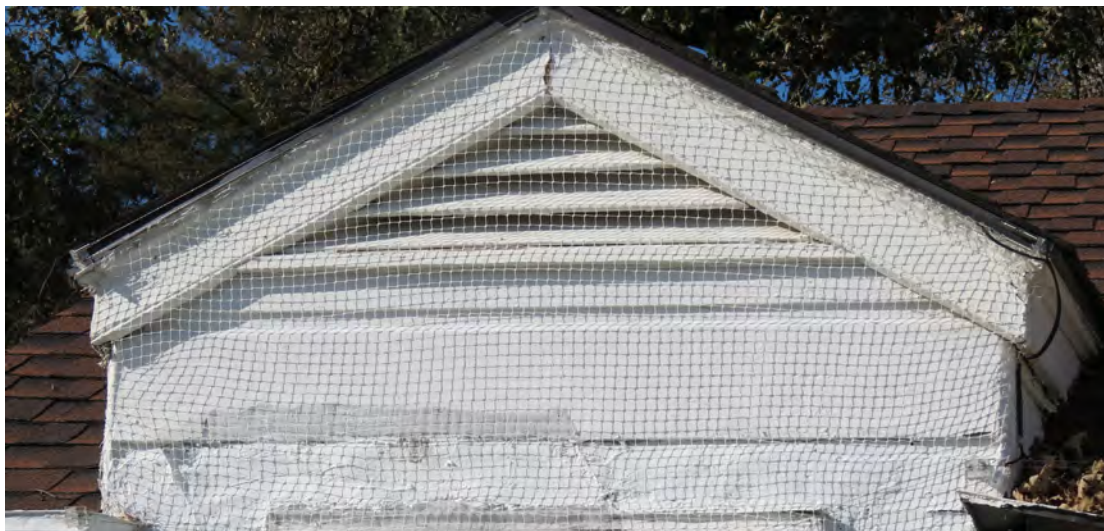
Figure 92. Dormer gable with woodpecker netting.

Description: General pests and destructive wildlife at the Grant Ranch include mice, squirrels, bats, gophers and woodpeckers. Wood destroying pests include wood boring insects and fungi. While an acorn woodpecker deterrent project was completed in 2009, woodpeckers still actively cause damage to wood elements on the structures (figure 92). The Main House has severe to moderate woodpecker damage. Termites are also causing damage to the wood elements on the structure.

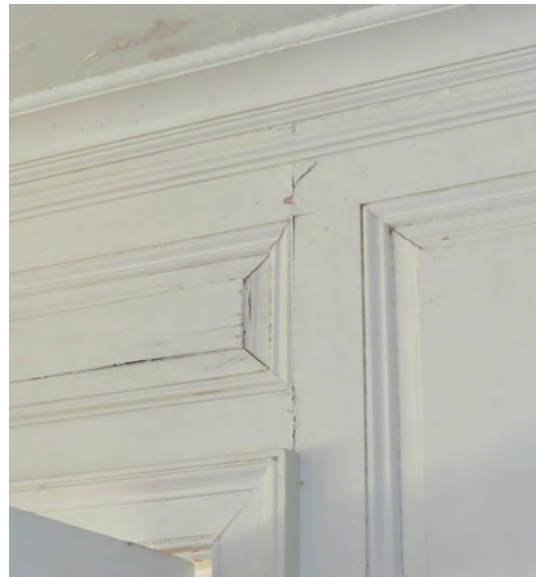
Figure 97. Water damaged painted wood paneling in Room 104.

Condition: The Main House walls range in condition from good to poor. The paneled walls in the main hall are in good condition while those in the living room are water damaged from an active leak, causing staining, peeling paint, and warping. Water damage also occurs in the sunroom and in bedroom 105 where the second floor balcony meets the exterior wall. Water has been allowed to pond on the porch roof deck, and subsequently leaks through the structure causing damage to the interior. Some water intrusion has caused damage below windows as well. The wood paneling in the living room has joint separation and the wall in bedroom 109 has severe staining and cracking

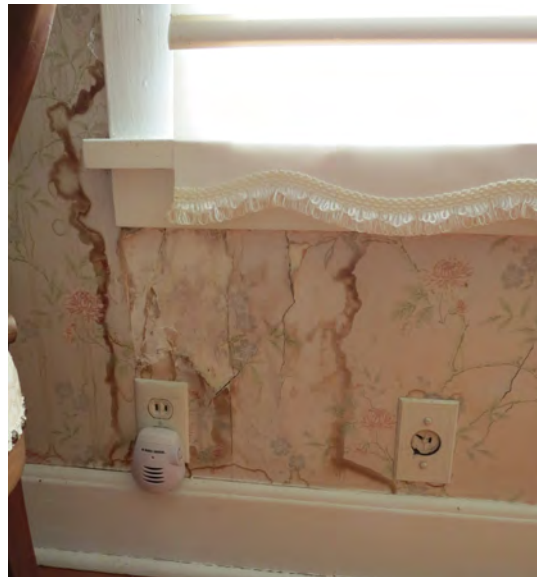
Figure 100. Water damage below window in Room 109.

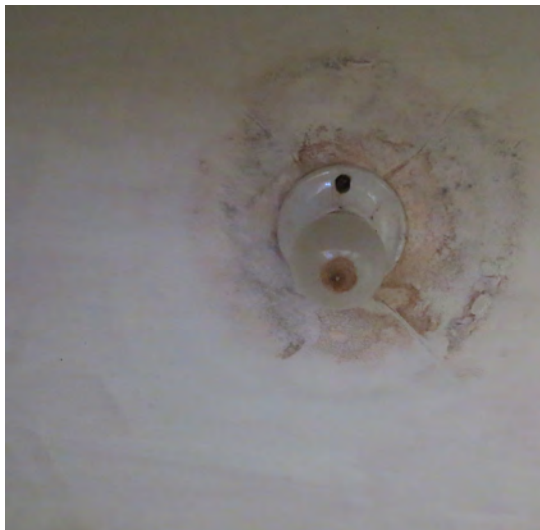
Figure 103. Water damage around light fixture in closet 105B.

- Fit replacement piece of gypsum board as closely to removed area as possible.
- Prep for paint or wall paper and finish to match existing adjacent surfaces.

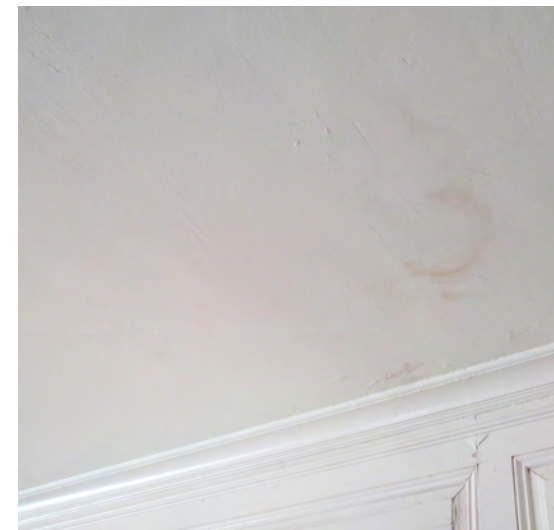
Figure 105. Water damaged gypsum board ceiling in Room 102.

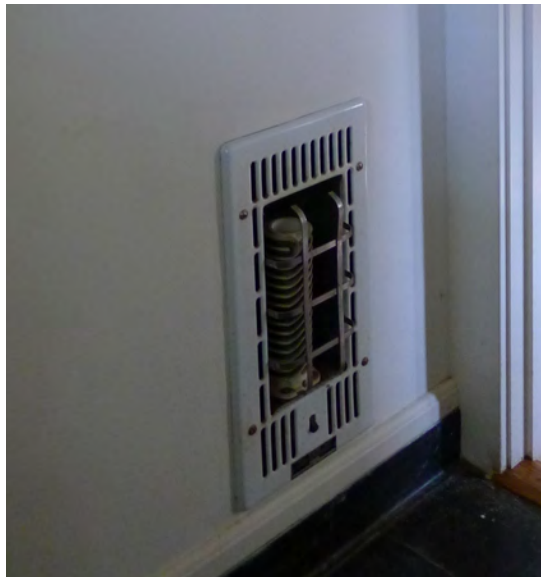
Electric Heater Co. are found throughout the Main House. In bathrooms, grille work is nickel with a white enamel border (figure 122). Two second floor bathrooms (202B, 208B) appear to have replacement heaters. Heaters in the main hall, living room, and Grant’s office have gunmetal grille work set within trim to match the paneling on the walls (figure 123). Bedrooms throughout have similar heaters installed beneath windows.

Condition: The wall mounted heaters are in good condition. Although dirty and rusted, nearly all of them still function.

Figure 122. Typical bathroom electrical heater.

Recommendations: Retain, repair and re-use original electric heaters.

- If continued use of existing heaters is deemed hazardous, abandon the elements in place.
- Carefully remove, salvage, label and store any components that must be removed for other work. Return these elements to their original locations when work is finished.

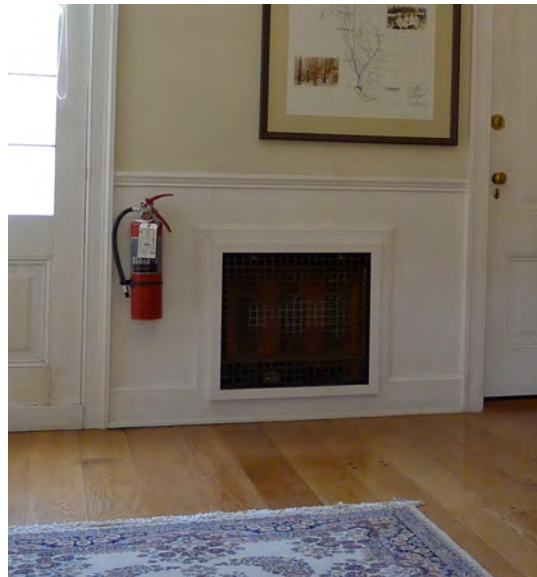
Figure 123. Wall mounted electric heater in Stairhall 201.

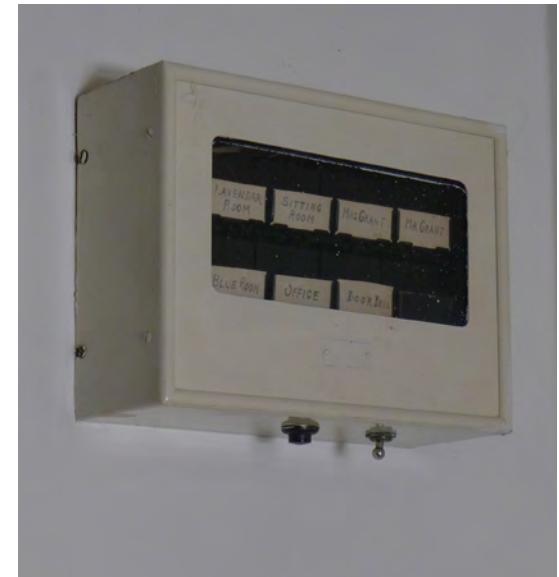
Figure 124. Push bell enunciator in Maid’s Room.

Another fitting found in the Main House is the maid call box, or “push bell enunciator system,” which is installed in the maid’s room (207) (figure 124).

Condition: These fittings are in good condition. The maid call box no longer operates.

Recommendation: Retain fittings in place. Carefully remove, salvage, label and store any components that must be removed for other work. Return these elements to their original locations when work is finished. Repair maid call boxes to working order.

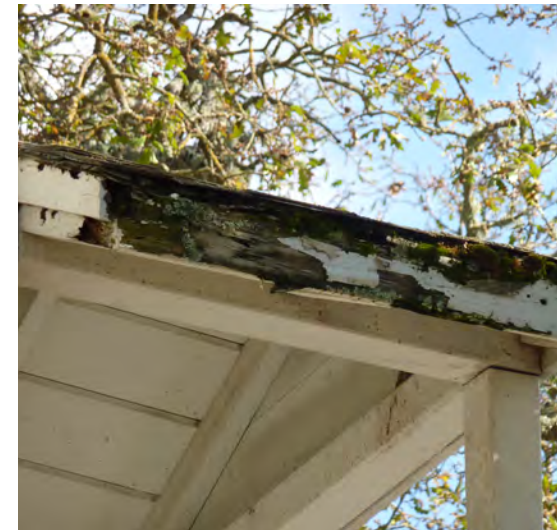
Condition: The visible composition shingles have heavy biological growth on the second floor door overhang (figure 127). The cornice around the upper level of the structure shows signs of water damage (figure 128) and the condition of the roofing at the tanks base is unknown. The condition the tank roof is unknown. See the Wood Siding section below, and the next, related section on drainage.

Figure 127. Biological growth at second floor gable roof.

Recommendations: A roof is a highly vulnerable element of any structure. It is also the first line of defense against water intrusion. Asphalt shingles have a finite life span and these assemblies will inevitably fail as a result of normal weather exposure and wear. A painted band of sheet metal was installed at the fascia boards of the tank and around the cornice of the upper level. The following are general recommendations:

- Survey the roof and tank for construction techniques, dimensions, design and material type. Photo document the existing conditions and record the survey data in existing conditions drawings.
- Deconstruct the roof and tank, salvaging any sound materials as well as the metal rings for reuse.
- Dispose of unused materials per sustainable building guidelines
- Reconstruct the tank and roof in new, in-kind materials, and sound salvaged materials based on the documented original design. The railing

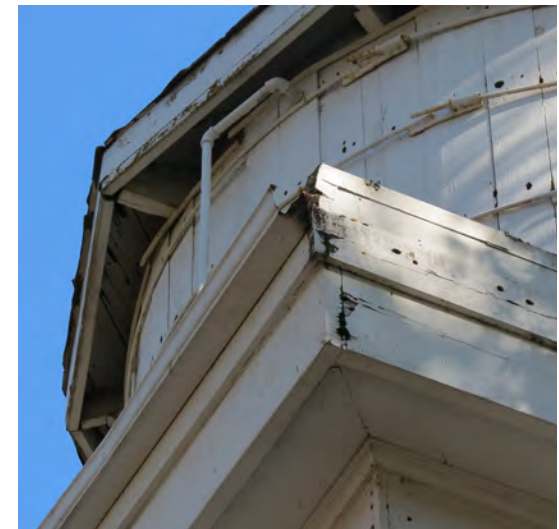
Figure 128. Damaged cornice and gutter on upper level of Tank House.

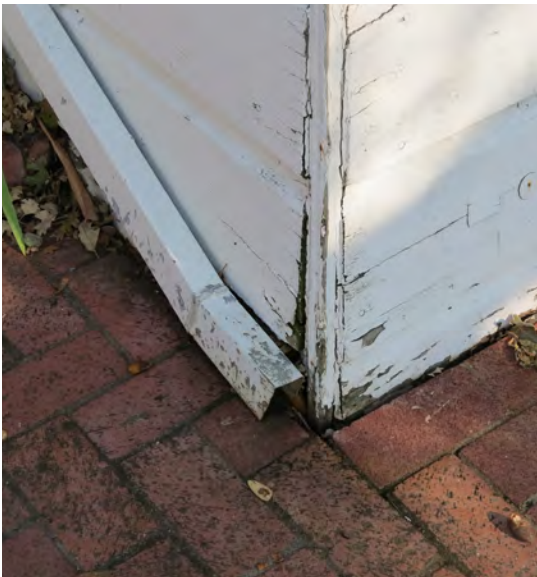
Condition: The existing gutter system is minimal on this structure. Located on the upper level of the tower on the northwest elevation is a leaking

downspout. Paint is peeling from the aluminum gutter and downspout, particularly on the under of the gutter. It is assumed that the upper gutter is filled with debris. Poor site drainage has caused the shiplap siding closest to the soil to deteriorate.

Figure 129. Deteriorating siding at downspout.

- Survey the gutters and downspouts for deterioration. Determine if they should be repaired or replaced.
- Survey the entire gutter system annually, noting leaks and deficient conditions, and repair as

To our knowledge there is no existing subsurface drainage system. Site drainage problems must be corrected so that water flows away from the building. This may be done by implementing some or all of the following:

- Tie all rain leaders to a perimeter drainage system that will carry all roof water away from the building.
- Re-grade soil on the northeast side of the building to create a positive slope away from the structure.

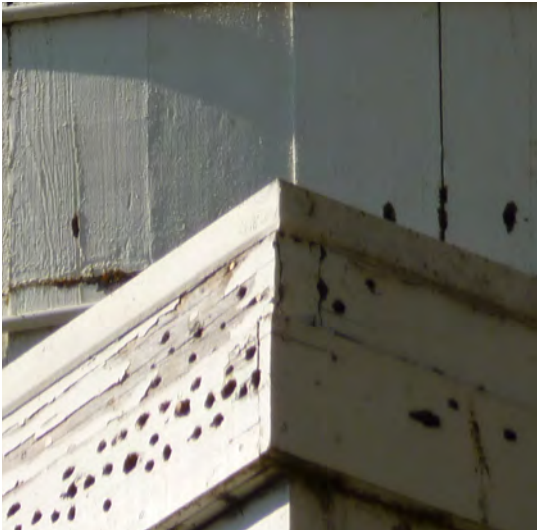
Figure 136. Woodpecker damage and missing paint at fascia.

Description: General pests and destructive wildlife at the Grant Ranch include mice, squirrels, bats, gophers and woodpeckers. Wood destroying pests include wood boring insects and fungi. The Tank House, particularly the water tank, has severe woodpecker damage (figures 136 & 141). Bats are currently living in the space between the Tank House and the Cook House.

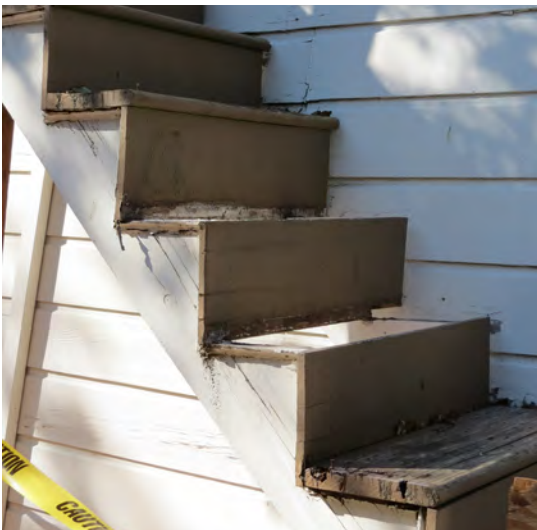
Figure 137. Deteriorating wood stair.

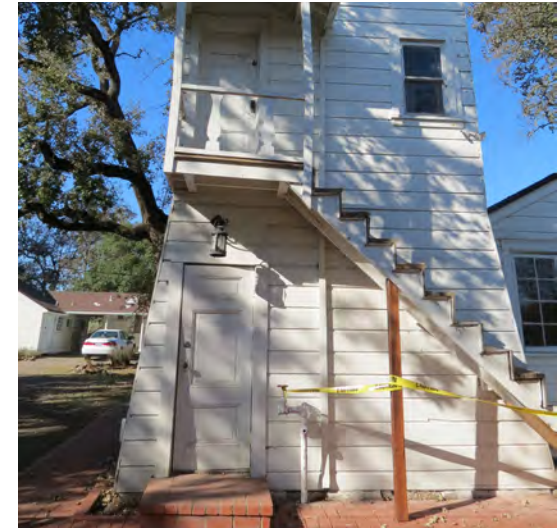
Figure 138. Structurally unstable exterior wood stair.

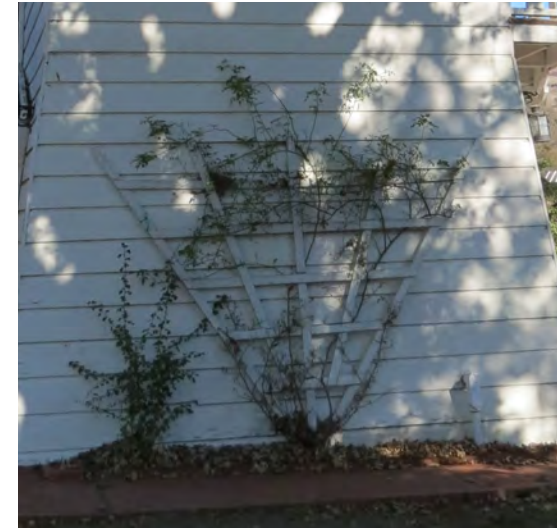
Condition: The cladding is in poor condition. Deterioration includes peeling and general deterioration of the paint, longitudinal cracking, water damage, woodpecker damage (figure 132), dirt build-up, biological growth, and some rust staining occurring at metal attachments and penetrations. Siding touches the soil in several places causing wood deterioration (figure 131). Paint and wood deterioration is severe near downspout (figure 129). Siding is cupped and twisted as the result of moisture infiltration. A large trellis with a climbing plant is very near to the siding on one elevation which could potentially lead to deteriora-

tion of wood because of trapped moisture. Refer to vegetation section below for recommendations on landscaping.

Description: Abundant landscaped vegetation historically existed on the site. A trellis with a climbing plant is located on the southwest elevation (figure 140). Several large branches from trees cantilever over the structure. Refer to landscape matrix to identify historic plantings.

Figure 140. Trellis with climbing plant against wood siding.

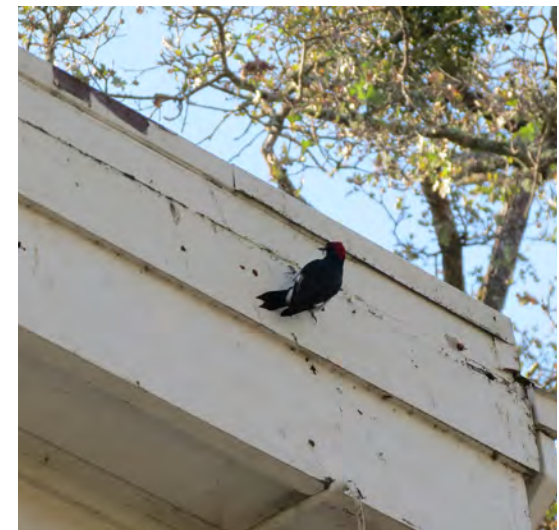
Woodpeckers have caused the most obvious damage to the wood siding and other wood elements on the building. Boards cladding the tank are severely damaged by woodpeckers (figure 130). The birds sit on the metal rings, holding the vertical stave boards in place, and peck at the wood. Address the wood siding repairs as follows:

Figure 141. Woodpecker causing damage to Tank House.

Recommendations: Perform a detailed cladding survey to identify conditions such as breaks,

cracks, loose or missing boards, insect and woodpecker damage, and biological growth. If structural repairs require removal of this material, it should be carefully salvaged, catalogued, and reinstalled at its original location. Apart from siding repairs, we recommend that the stave-built water tank and roof be reconstructed rather than repaired. General recommendations are as follows:

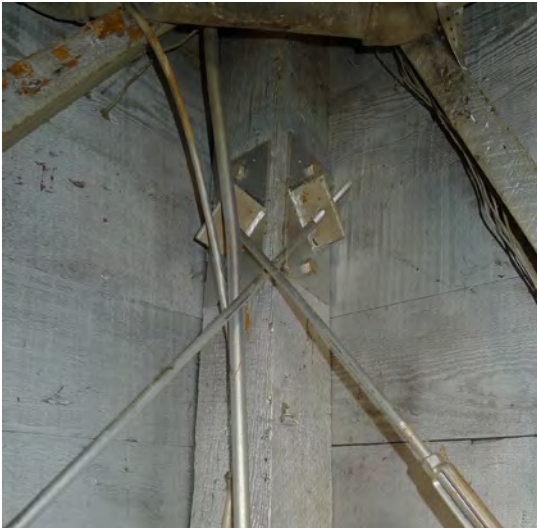
Figure 142. Diagonal ties and exposed wood framing.

Description: The Tank House interior walls consist of exposed timber framing and the horizontal exterior siding. Diagonal 2x4 bracing between the timber framing appear somewhat haphazardly placed. Metal diagonal ties have been installed to further stabilize the structure (figure 142). All interior surfaces have been painted silver.

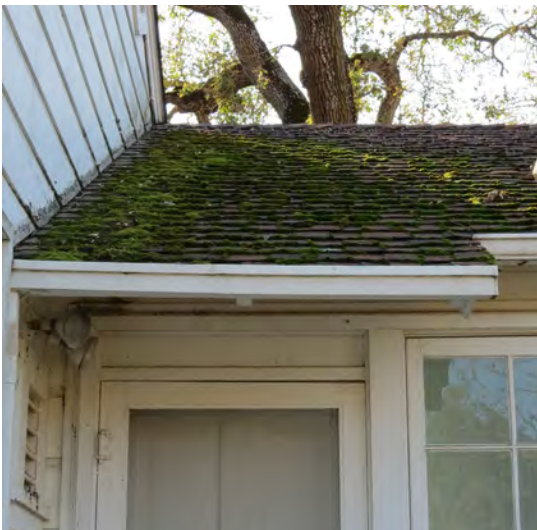
Figure 158. Roof with heavy biological growth.

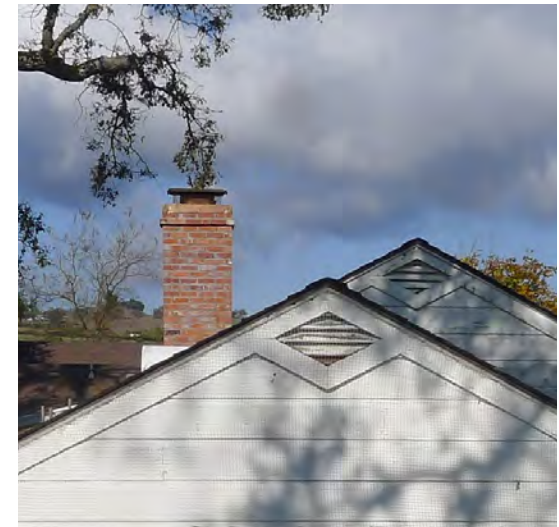
Description: A brick interior chimney sits in the middle of the structure to the west of the roof ridge (figure 159). A single row brick veneer lines the concrete foundation on the southeast elevation. A wide raised brick porch lines the southwest elevation.

Condition: The chimney has been recently rebuilt and stabilized and is in good condition. The brick veneer is in fair condition with signs of water infiltration and biological growth on the surface. The porch on the southwest elevation is in good condition and has only a few cracks, some the width of the porch (figure 160). Several bricks at the northern corner of the porch have sections broken off.

Figure 159. Brick interior chimney.

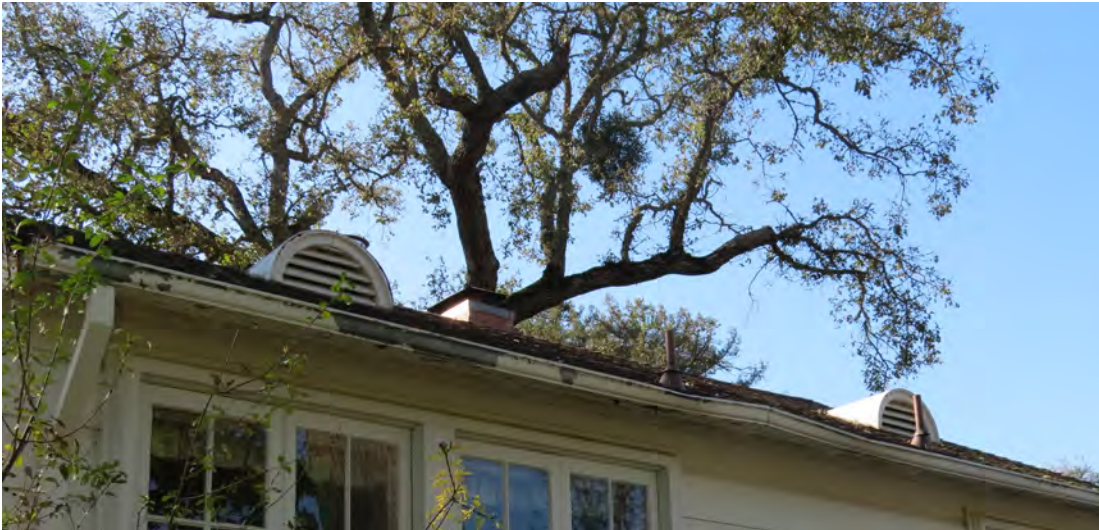
Figure 161. Detached gutter with paint loss.

Condition: Gutters are filled with debris in many locations. Several downspouts are detached and leaking (figure 161), contributing to the staining and biological growth on the wood siding and eaves. The gutters have significant paint loss, especially on the underside (figure 162). Flashing between the different roof sections is missing or severely deteriorated. The lack of proper flashing has caused nearby wood to lose paint and deteriorate. Poor site drainage has caused the shiplap siding closest to the soil to deteriorate.

Recommendations: The metal fascia gutters are not historic and should be replaced in-kind with copper painted to match the building. The repair

- Survey the gutters for deterioration. Determine if they should be repaired or replaced.
- Replace badly deteriorated or missing gutter sections to match original.
- Replace damaged rainwater leaders with new copper units, painted to match the building. New rain leaders should be sized to carry the amount of water shed by the tributary area of the roof.
- Survey the entire gutter system annually, noting leaks and deficient conditions, and repair as needed.
- Clean gutters at least twice annually, as part of the building's regular maintenance.

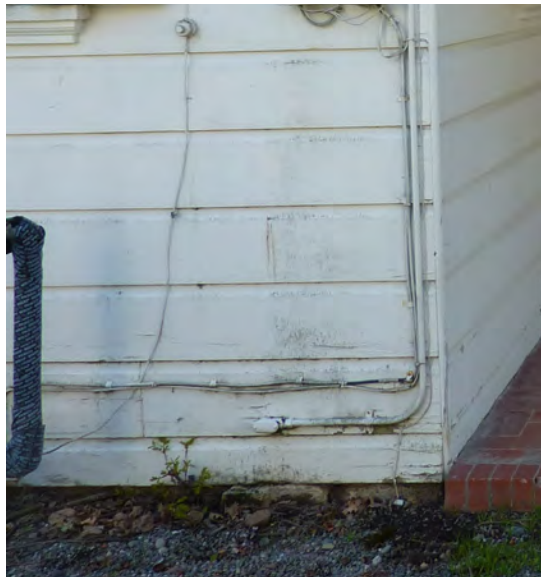
water damage, woodpecker damage, dirt build-up, biological growth, and some rust staining occurring at metal attachments and penetrations (figure 163). Biological growth is especially prevalent on the northwest side of the building. In several locations the siding is in contact with the soil causing accelerated wood deterioration at these areas (figure 165). Where siding and roof shingles meet, at the north and south additions, wood deterioration is evident (figure 164). Metal louvered vents at the crawl space are painted and some of the louvers are bent.

Figure 165. Paint loss and wood deterioration near foundation.

- Prior to repairing siding, repair areas of water intrusion where moisture penetrates the wall from above.
- Remove dirt, debris and miscellaneous non-functional attachments.
- Replace any broken or deteriorated boards in-kind. Pre-treat with wood preservative and back-prime all surfaces prior to installation.
- Patch and repair wood damage from woodpeckers with epoxy consolidant and repair compound for use on wood..

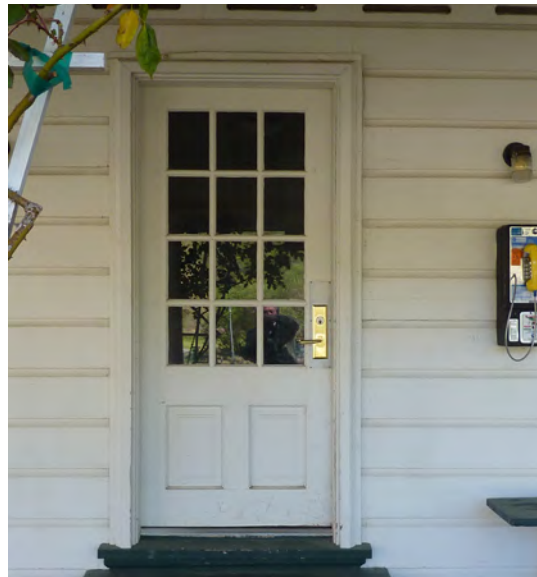
Description: Two 12-lite over two-panel wood doors are located on the southwest elevation (figure 166). One door has a screen. A four-panel door is found on the northeast elevation (figure 167).

Condition: The doors and screen door are in fair condition, condition varies depending on weather exposure, type of door, and state of repair. Paint is peeling and deteriorating on all doors. The glazing compound is failing at many of the panes, trapping water between the wood and the glazing, speeding up wood deterioration. Two of the three

Figure 166. 12-lite over two-panel wood door on southwest elevation.
