HISTORIC STRUCTURES REPORT

GRANT RANCH HOUSE COMPLEX

JOSEPH D. GRANT COUNTY PARK

Final Report
November 7, 2012

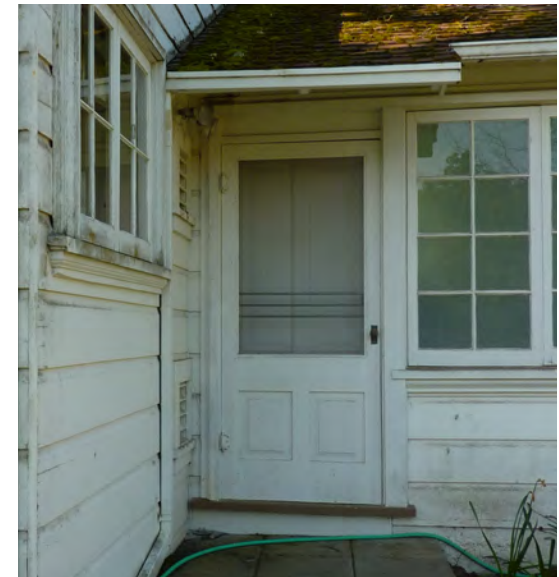
Description: Two 12-lite over two-panel wood doors are located on the southwest elevation (figure 166). One door has a screen. A four-panel door is found on the northeast elevation (figure 167).

Figure 167. Four-panel wood door.

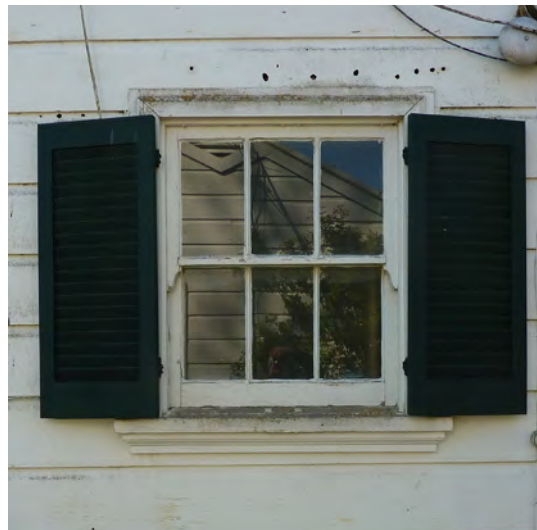
Condition: The trim around the windows and doors under the large overhang is in good condition, while trim around the more exposed windows and doors is weathered. Biological growth is primarily on the window sills and other horizontal trim members where water is allowed to stand (figure 169).

Figure 169. Double hung window with biological growth covering trim and shutters in good condition.

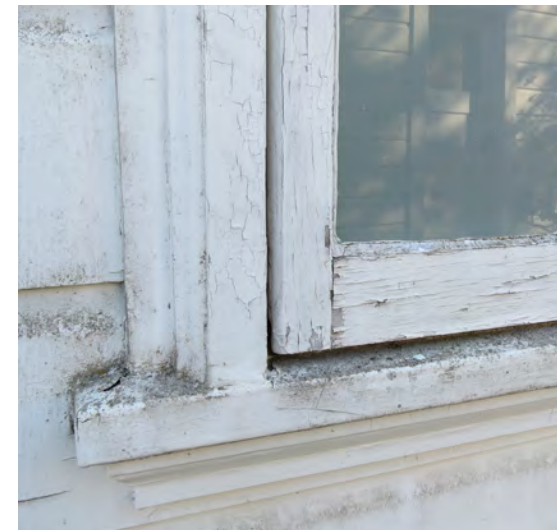
Figure 170. Wood window with paint loss and glazing compound deterioration.

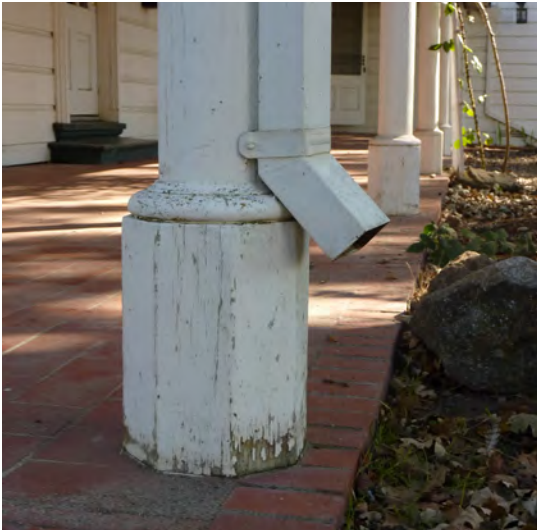
Figure 171. Paint loss at base of column.

Condition: At the base of the columns the wood is weathered and paint loss occurs (figure 171). The upper portions of the columns are not as exposed and are in better condition. The northernmost column, with the downspout, is more deteriorated than the rest due to water leaking from the downspout onto the wood surface. The painted surface of the columns displays mold growth. The mold is most prevalent on horizontal details where water is able to stand for long periods.

Recommendations: For minor repairs to wood columns:

- Survey and examine in detail the existing condition of all wood columns.
- Remove all dirt and debris.
- Remove paint to obtain clean surface where repairs are required.
- Patch and repair deteriorated wood with wood Dutchman patches or an epoxy consolidant or compound appropriate for use on soft wood.
- Where the severity of deterioration precludes repair, replace the columns with in-kind materials, and the original design profile.
- Prepare wood surfaces prime and paint to match historic finish. For new posts, back prime the end grain bearing points before installing.

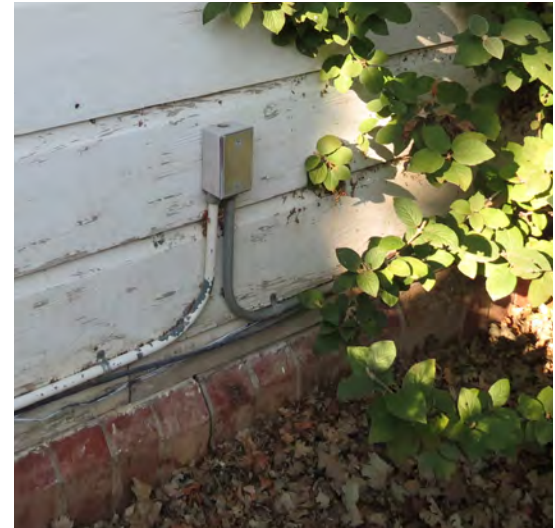
Figure 173. Brick with cracked mortar cladding concrete foundation.

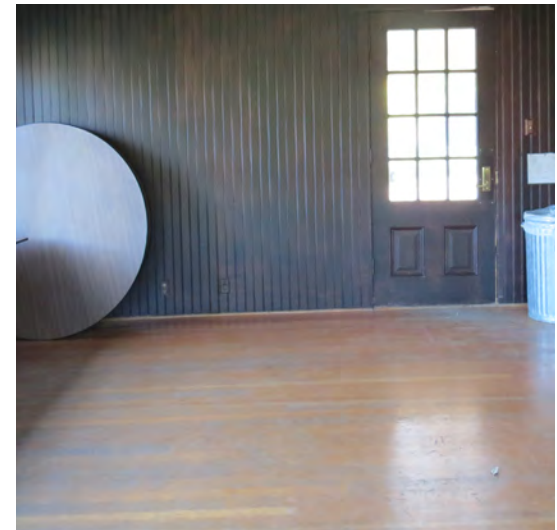
Condition: Floor finishes in the Cook House are in fair condition. The wood flooring is heavily worn and scratched (figure 177). The sheet vinyl is also generally worn, scratched, and curling around the edges and seams. There is a large hole in the vinyl near the fireplace in Room 102. In the kitchen, the subfloor near the sink seems to be failing as it sags under foot, possibly suffering from water damage due to leaking plumbing and termites (figure 178).

Figure 177. Heavily worn wood floor in Room 101.

- Survey floors in detail for damage. Conduct finish analysis on wood floors to determine historic finishes.
- Use the gentlest means possible to remove adhesives from areas beneath the vinyl. Use all legal means in handling and disposal of asbestos-containing materials.
- Repair wood floors. Patch damaged areas in kind (Douglas Fir). Clean existing finish if possible, or refinish to match historic treatment. Refinishing should be limited to severely worn

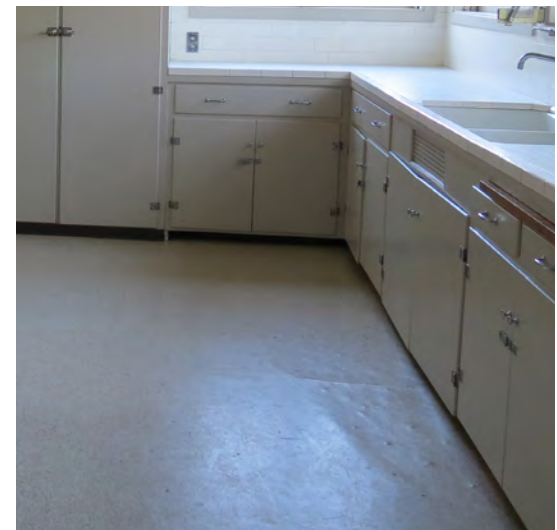
Figure 178. Sheet vinyl flooring in kitchen showing evidence of subfloor damage.

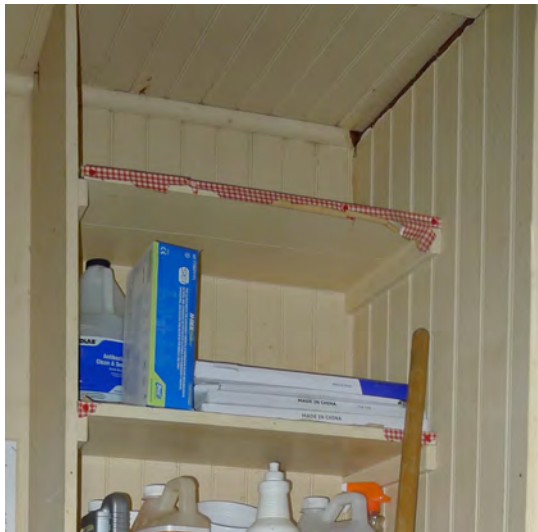
Figure 183. Bead board walls and ceiling in Room 105A.

Condition: The ceilings in the Cook House are in good condition overall. Minor cracks appear in the gypsum board ceilings. In the closet (105A), the painted bead board ceiling has some water staining (figure 183).

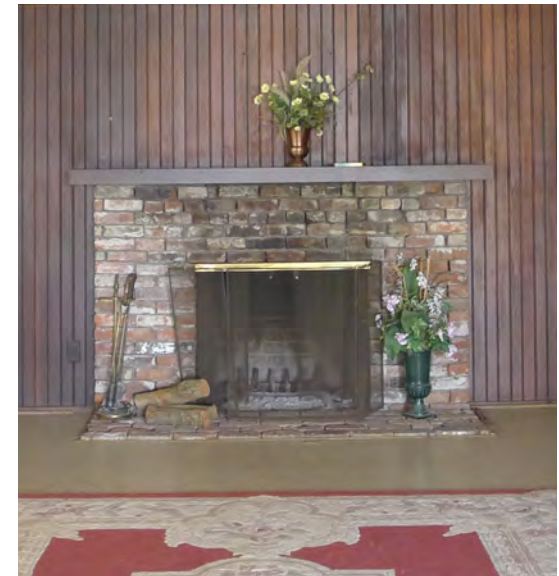
Condition: The Cook House fireplace is in fair condition. The mortar joints have minor cracks, and several of the bricks in the hearth have been severely cracked or broken.

Figure 188. Fireplace in Room 102.

Recommendations: Clean the soot stains on the surrounds and mantels using the gentlest means possible. Conduct a detailed survey to determine any area of needed repair, and address brick repairs as follows:

Masonry Repointing. Repoint deteriorated, loose, missing and improperly installed mortar.

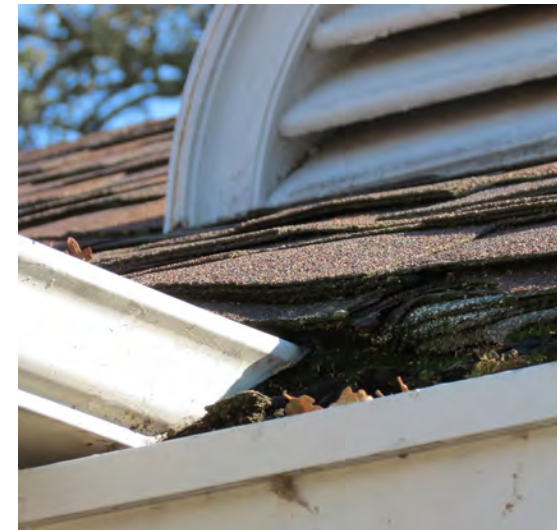
Figure 210. Multiple layers of roofing material.

Description: The asphalt composition shingles cover several layers of older roofing material (figure 210). It is likely that both composition and wood shingles are under the existing exterior layer. Several painted wood louvered attic vents penetrate the roof.

- Replace damaged asphalt shingles with shingles to match size, color, and exposure of original. Class A fire rated asphalt composition shingles with a 40-year life span are recommended.

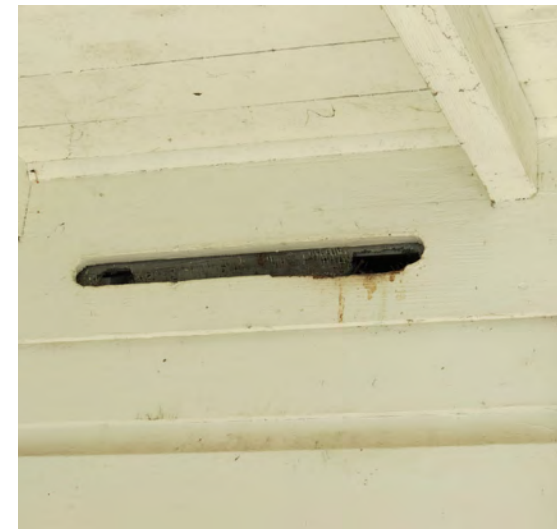
Figure 211. Mesh-covered vent in frieze board.

The frieze boards have large vents in between the rafters which are covered with mesh (figure 211). Some mesh is missing or has holes allowing pests to enter the attic area. A quarter round trim piece adds detail to the fascia and helps secure the metal flashing. The painted louvered attic vents are covered in mold and have severe paint loss in areas closest to the shingles (figure 213). The wood siding has paint loss where the roof adjoins it (figure 214). The garage roof is sagging which could indicate a possible structural issue. Also, see the next, related section on drainage. There are two known active leaks in the building.

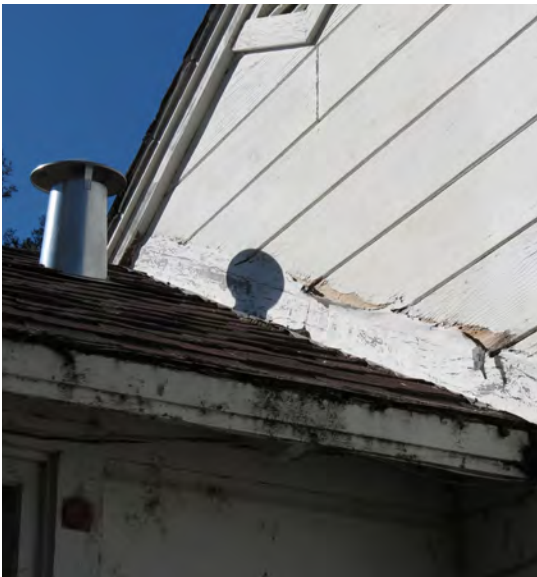
Figure 214. Paint loss at intersection of roof and wood siding.

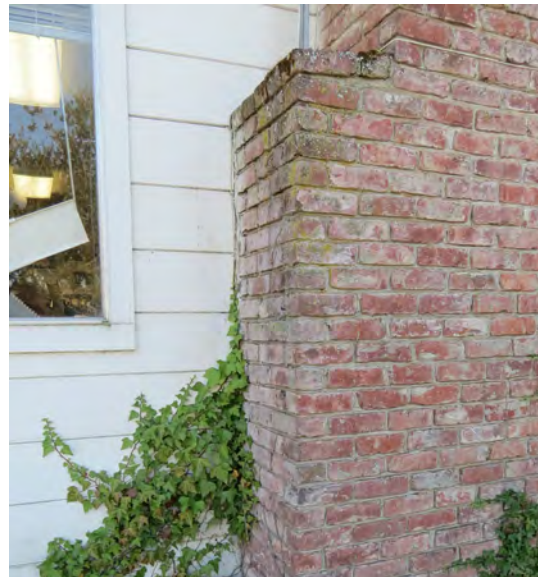
end addition has ivy growing up the brick stack. Both brick chimneys display biological growth, particularly on the lower portion. The mortar has minor cracks on the 1960s chimney and the older chimney has biological growth on the surface of the bricks and mortar (figures 215 & 216).

Figure 215. Biological growth on brick chimney at 1960s addition.

mendations listed in the drainage discussion below. Remove ivy from the surface of the brick and maintain plantings to prevent damage caused by plantings on surface material. Currently no repointing is necessary on the southeastern chimney; however, the chimney that is part of the 1960s addition should be inspected for mortar failure. Both fireplaces should be inspected for mortar failure. There are currently no areas of missing brick; however many of the bricks near the soil have clear evidence water infiltration and biological growth. Implement drainage measures and then, if required, repair brick masonry as follows:

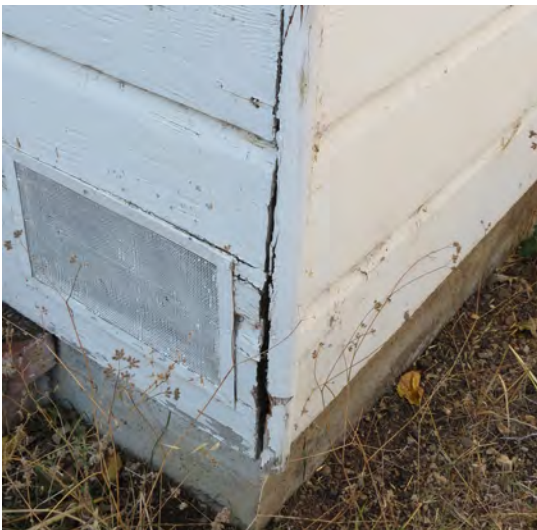
Figure 220. Deteriorating wood siding near foundation.

Condition: The cladding is in fair to poor condition. Deterioration includes peeling and general deterioration of the paint, longitudinal cracking, water damage, woodpecker damage, dirt build-up, biological growth, and some rust staining occurring at metal attachments and penetrations. Wood deterioration and extensive paint loss occurs where the wood siding touches soil (figure 220). The painted siding displays water staining in several locations. The siding has minor woodpecker damage. The metal louvered vents at the crawl space have surface mold. In a number of locations, the vents are missing and the hole is covered by metal mesh. Ivy is growing up the siding on the most recent addition which will

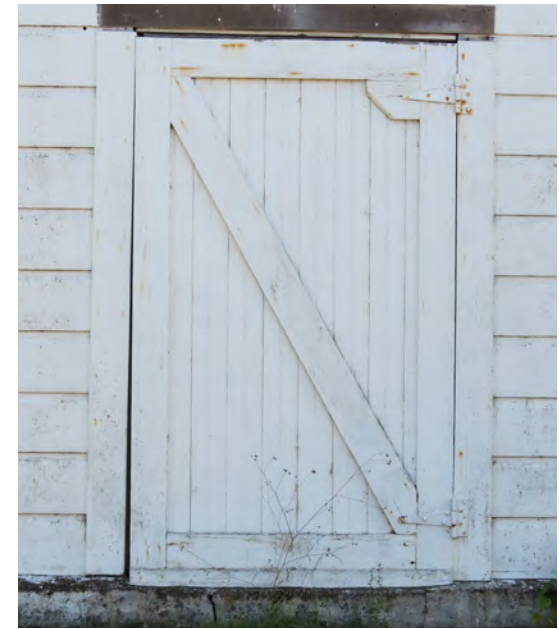
Condition: The doors and screen doors are in fair condition, condition varies depending on weather exposure, type of door, and state of repair. Most of the doors have been altered slightly by the removal of original locks which were replaced with modern latching and locking mechanisms. The glazing compound is failing at many of the panes, trapping water between the wood and glazing, speeding up wood deterioration. Many of the thresholds are worn and weathered. Repair existing doors as follows:

Figure 221. Frame-and-fill door at Room 119.

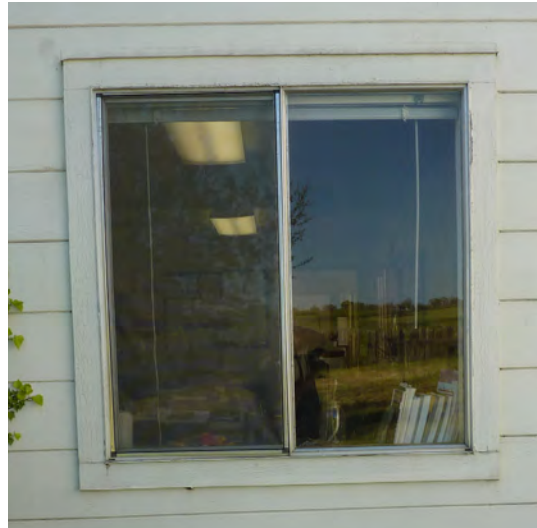
Figure 223. Non-contributing aluminum window at 1960s addition.

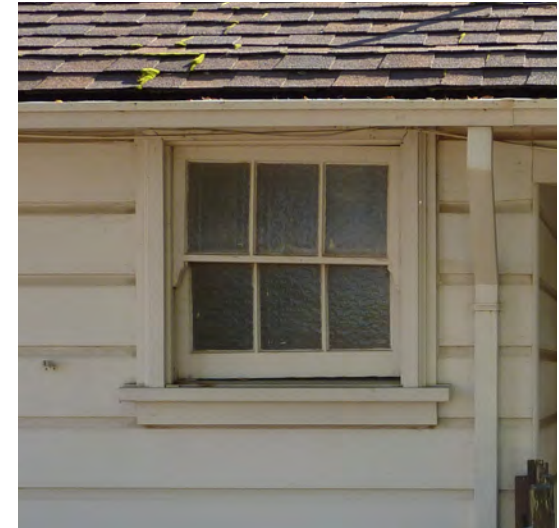
Condition: The windows are in fair to poor condition. The exterior paint is deteriorated at many of the windows. Joint separation between the wood members occurs at many of the windows. Much of the glazing compound is dried, cracked or missing. In addition to lead in the existing paint, asbestos may be found in the glazing compound. Several of the windows have cracked panes. Windows and their sills on all sides of the building have black biological growth stains (figure 225). It appears that much of the original hardware is intact, but the actual extent should be determined by a survey. Some of the windows are not aligned properly in their frames, causing large gaps and allowing water and pests to enter the building (figure 224). The aluminum windows are rusting and it is not known if they are operational. Repair existing wood windows as follows:

Figure 224. Out-of-plumb double hung wood window.

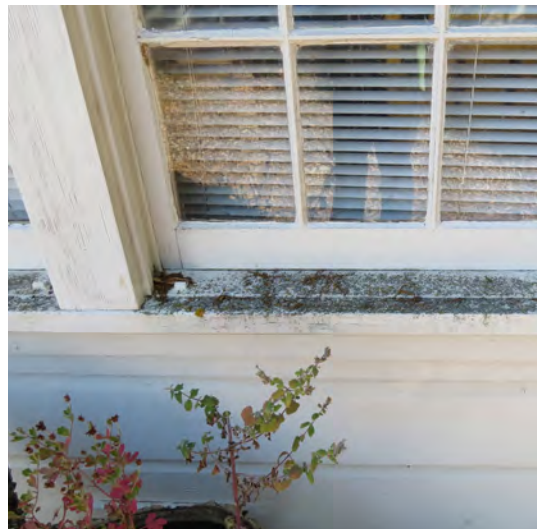
Figure 225. Mold growth on painted wood window sill.

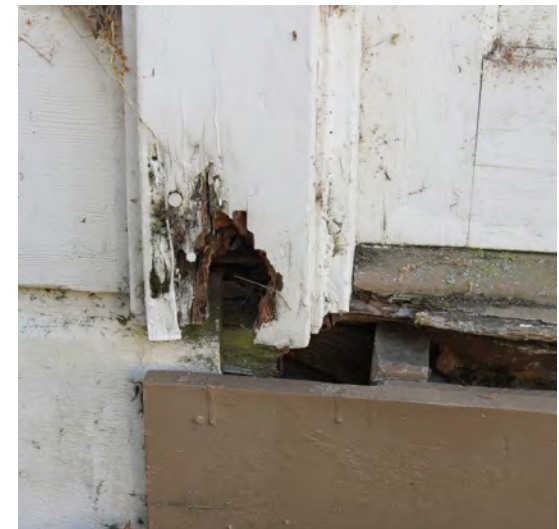
Condition: Paint is peeling on many of the trim elements and separation is visible between the joints of trim members. Nails are rusting, causing staining on the painted surfaces. Wood deterioration occurs at horizontal surfaces such as sills. Mold is evident on painted trim, particularly the sills, where water can stand. Deterioration of wood and paint on door trim is more severe near the ground (figure 226). A top piece of door trim is missing from one of the door surrounds.

Figure 226. Deteriorated wood door trim.

- Remove dirt and debris.
- Replace any broken or deteriorated trim pieces in-kind. Pre-treat with wood preservative and back-prime all surfaces prior to installation.
- Patch and repair wood damage from woodpeckers with wood Dutchman or epoxy consolidant or repair compound formulated for wood.
- Reattach any loose elements with stainless steel fasteners.
- Patch and repair wood damage from woodpeckers with epoxy consolidant or repair compound

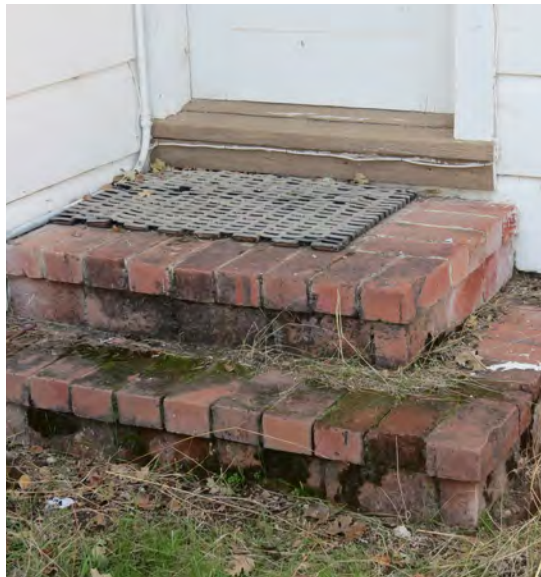
deteriorating mortar joints (figure 229). The wood columns and posts are deteriorating due to moisture intrusion see pervious section for repair recommendations for columns and posts. Follow the repair or replacement procedures as follows:

Figure 229. Brick steps with heavy biological growth and deteriorating mortar.

Recommendations: For brick repairs refer to earlier section on chimneys. For concrete, repair as follows:

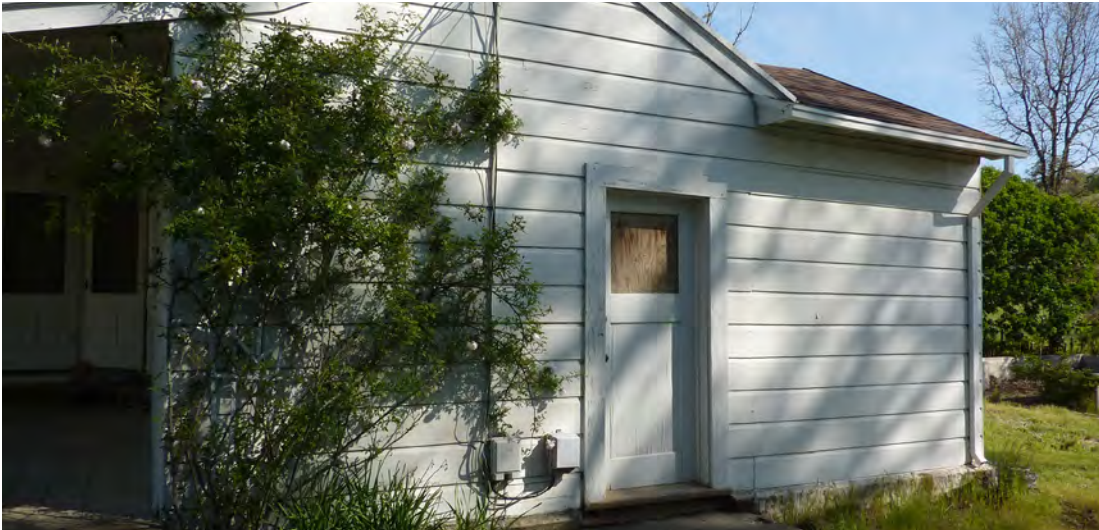
Figure 235. Trellis with climbing plant against Guest House wood siding.

Description: Abundant landscaped vegetation historically existed on the site. Today, foundation plantings grow against the Guest House on some sides with trees in close proximity to the structure (figure 235). Several of the plantings are bushes. Ivy has also started to climb the chimney and wood siding on the northwest elevation of the 1960s addition (figure 236). Refer to landscape matrix to identify historic plantings.

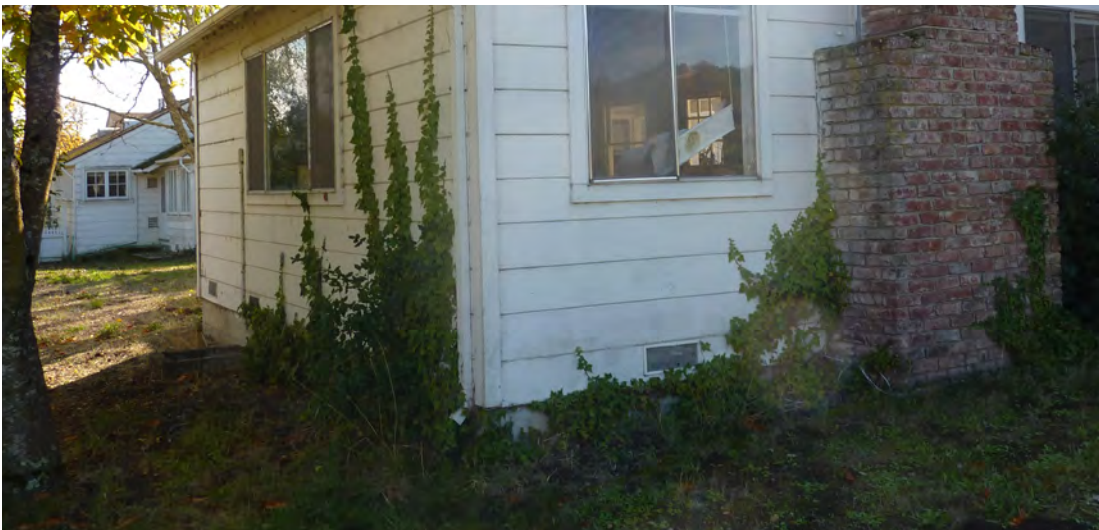
Figure 236. Climbing plant against Guest House wood siding.

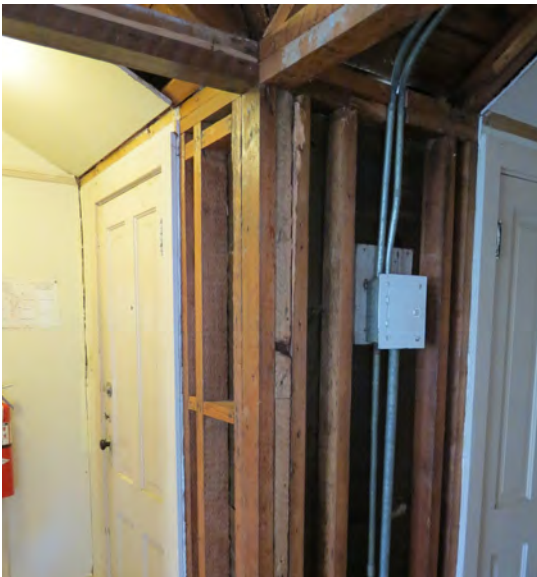
Figure 241. Severe damage at junction between rooms 103, 103A and 103B.

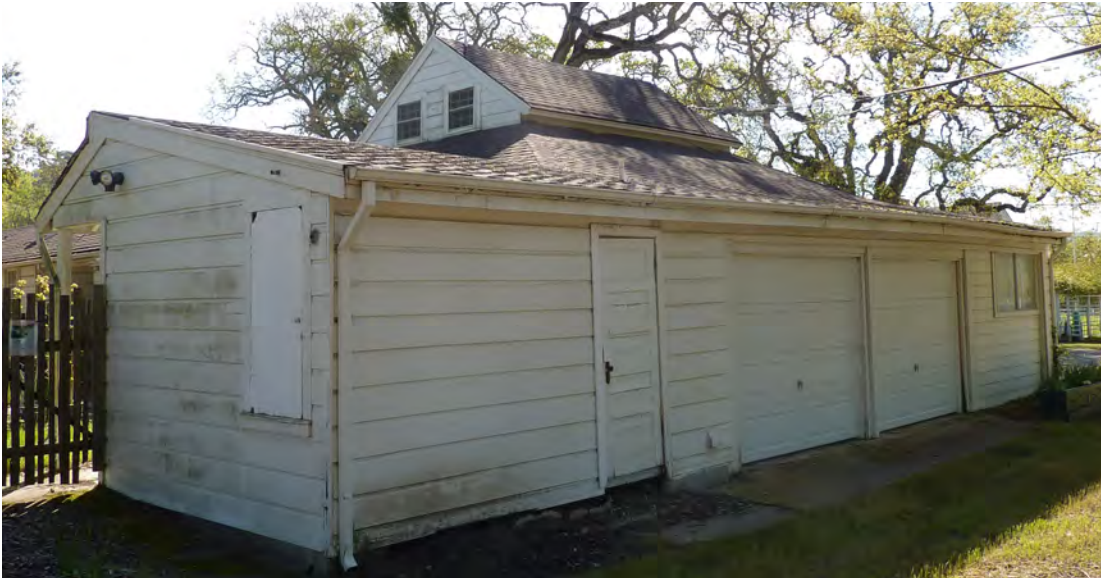
Figure 274. Southwest and Northwest Elevations.

The overall condition of the exterior of the Carriage House is fair (figure 274). Settlement of the foundation is causing cracks and holes in the foundation. The exterior siding exhibits paint failure and some wood deterioration, particularly

Prior to any work survey all exterior materials at close range to identify and locate all deterioration and deficiencies. Stabilize and repair existing historically significant materials. Replace missing components in-kind where required. Minimize the impact of visible modifications to the exterior elevations.

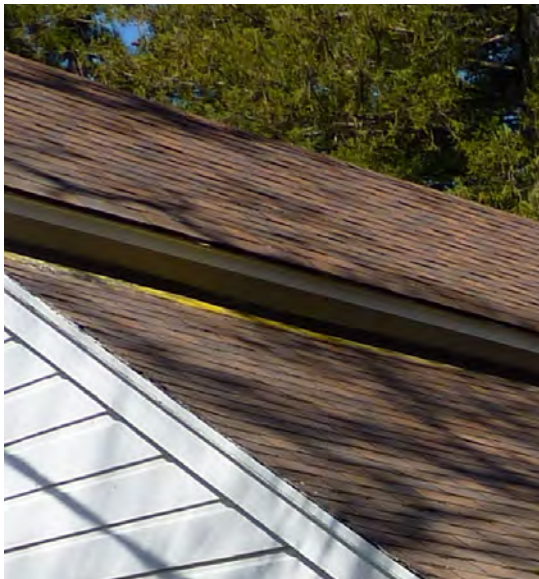
Figure 276. Yellow biological growth at second story eave.

Condition: The composition shingles have areas with heavy biological growth (figures 275 & 276). In areas that are shaded or where water stands for long periods, there is extensive biological growth. Flashing also appears to be installed improperly or is not visible. Expose rafters and sheathing are deteriorating due to moisture infiltration.

- Replace damaged asphalt shingles with shingles to match size, historic color, and exposure of original. Class A fire rated asphalt composition shingles with a 40-year life span are recommended. Historic color of shingles was green and this layer might be visible under other layer of roofing material.

- Replace all flashings with copper for longevity.
- Clean and maintain gutters and leaders on a regular basis. Clogs in these systems will cause water to back up and seep into the adjacent sheathing and wall top plate.

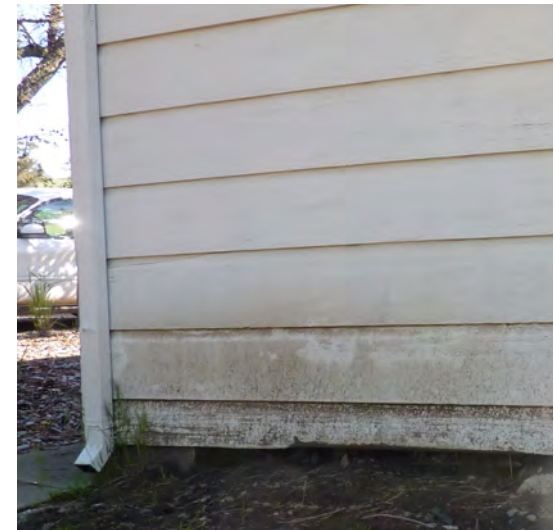
Condition: The shiplap cladding is in fair condition. Deterioration includes peeling and general deterioration of the paint, longitudinal cracking, water damage, dirt build-up, biological growth, and some rust staining occurring at metal attachments and penetrations. Wood deterioration and extensive paint loss occurs where the wood siding touches soil (figure 280). A sheet of metal was used as a patch at one location on the southeast side. Siding on the second floor is deteriorating where it abuts roof shingles. Flashing at these connections is missing or not installed properly. A large hole remains in the siding where a light fixture once was (figure 281). Some of the siding has been patched. A buildup of bat guano on the siding is accelerating the deterioration of the wood. The metal louvered vents at the crawl space have mold on the surface.

Figure 280. Deterioration and biological growth at siding.

Recommendations: Perform a detailed cladding survey to identify conditions such as breaks, cracks, loose or missing boards, insect damage, and biological growth. If structural repairs require removal of this material, it should be carefully salvaged, catalogued, and reinstalled at its original location. General recommendations are as follows:

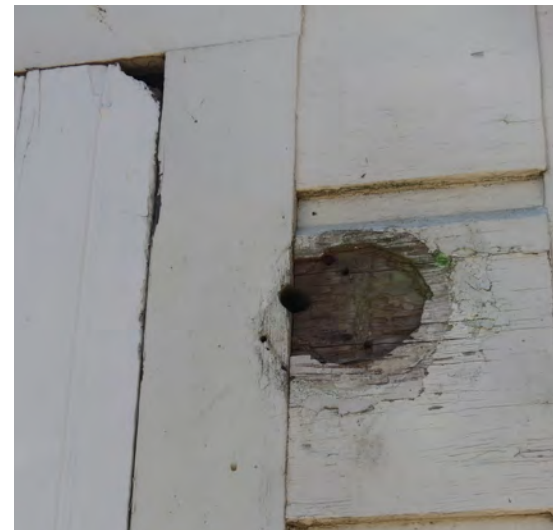
Figure 281. Large hole from removed light fixture.

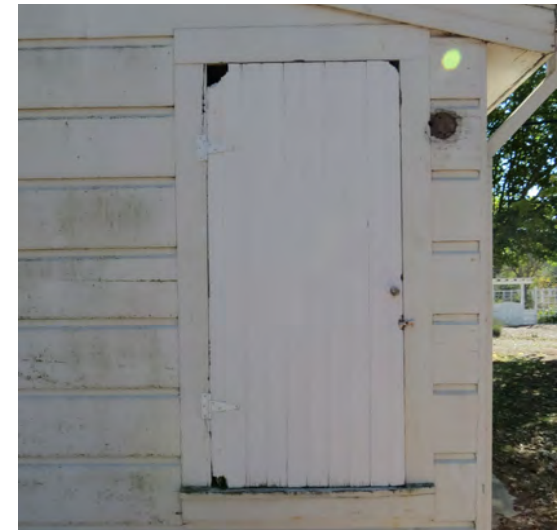
Figure 284. Wood deterioration at half size door.

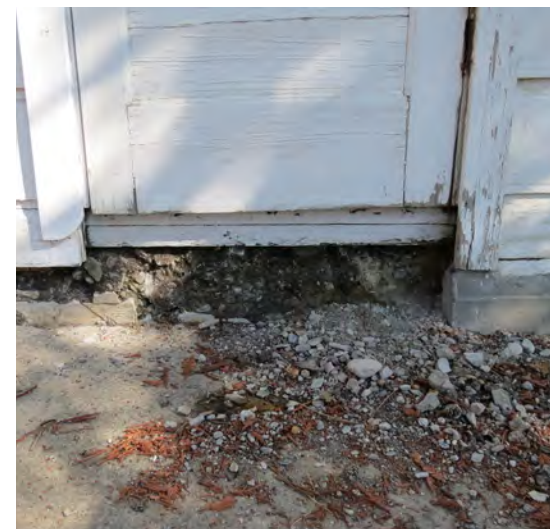
Condition: The trim around the windows and doors are in fair condition (figures 286 & 287). Paint is peeling on many of the trim elements. Nails are rusting, staining the painted surfaces. Separation is visible between joints. Wood deterioration and biological growth occurs at horizontal surfaces, including the sills. Poorly installed flashing above the trim is trapping water, causing wood and paint deterioration. Deterioration of wood and paint on door trim is worse closer to the ground. Address the wood trim repairs as follows:
Recommendations: Perform a detailed wood trim survey to identify conditions such as breaks,

Figure 287. Door and trim deterioration near soil.

cracks, loose or missing, insect and woodpecker damage, and biological growth. If structural repairs require removal of this material, it should be carefully salvaged, catalogued, and reinstalled at its original location. General recommendations are as follows:

- Remove dirt and debris.
- Replace any broken or deteriorated trim pieces in-kind. Pre-treat with wood preservative and back-prime all surfaces prior to installation.
- Patch and repair wood damage from woodpeckers with epoxy consolidant or repair compound formulated for wood.
- Reattach any loose elements with stainless steel fasteners.

- Treat with a fungicide if required, then prime and paint. Include fungicide in the paint to discourage future biological growth.
- Repaint using historically appropriate paint colors.

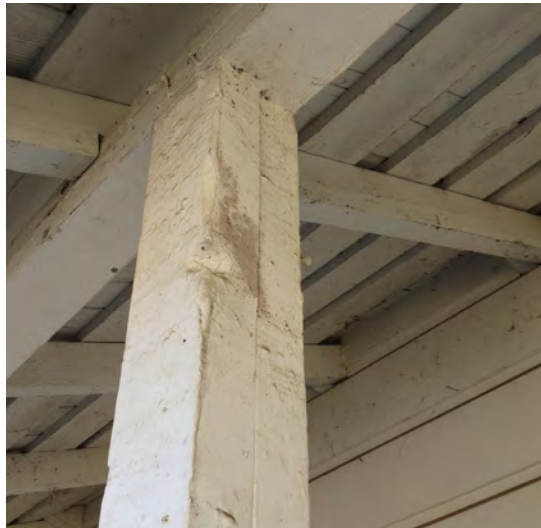
Figure 288. 2x4 wood studs used for post.

painted and constructed from two 2x4 wood studs (figure 288). The octagonal painted bases are constructed of wood and have mitered corners.

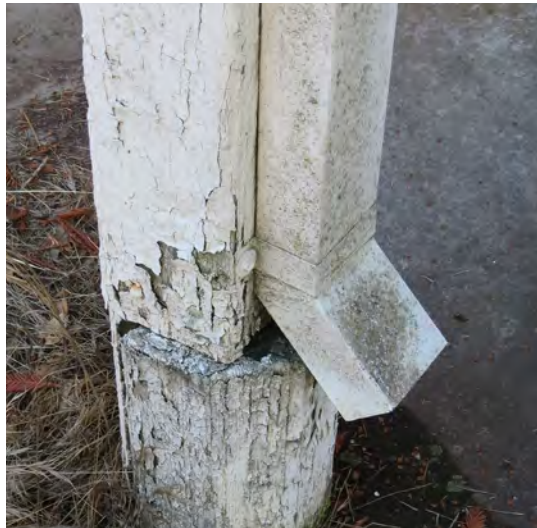
Figure 289. Deterioration at base of posts.

Wood is deteriorating near the base of the posts due to moisture. The post with the downspout is severely deteriorated (figure 289). The painted wood beam that the posts support is covered in mold and shows signs of water damage beneath the paint. Layers of paint have encapsulated animal waste on the posts.

- Survey and examine in detail the existing condition of all wood posts.
- Remove all dirt and debris.
- Remove paint to obtain clean surface where repairs are required.
- Patch and repair deteriorated wood with wood Dutchman patches or an epoxy consolidant or compound appropriate for use on soft wood.
- Where the severity of deterioration precludes repair, replace the columns with in-kind materials, and the original design profile.
- Prepare wood surfaces prime and paint to match historic finish. For new posts, back prime the end grain bearing points before installing.

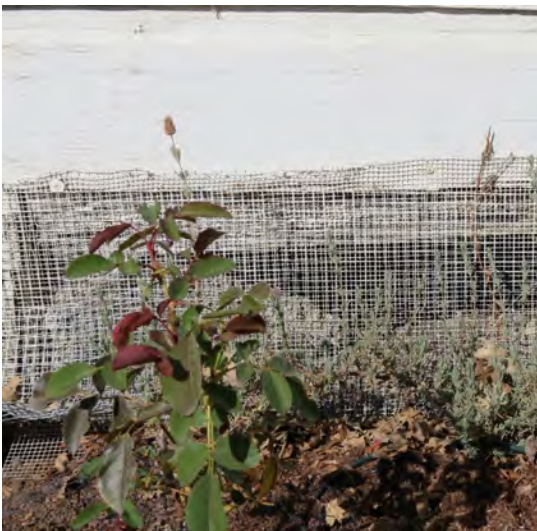
Figure 291. Mesh covering hole at foundation.

Condition: The concrete foundation exhibits settlement problems causing cracks, many of them major. The large aggregate is crumbling from the concrete where large cracks occur. There are also places where the foundation has severely crumbled leaving holes to the crawl space below the building. Wire mesh covers the entire southeast side foundation to keep animals out (figure 291). Biological growth occurs at various locations on the foundation. The concrete slab in the garage area and two storage areas have major cracks causing sections of the slab to be uneven. Wildlife is able to enter the building through holes in the foundation that have not been covered with mesh.

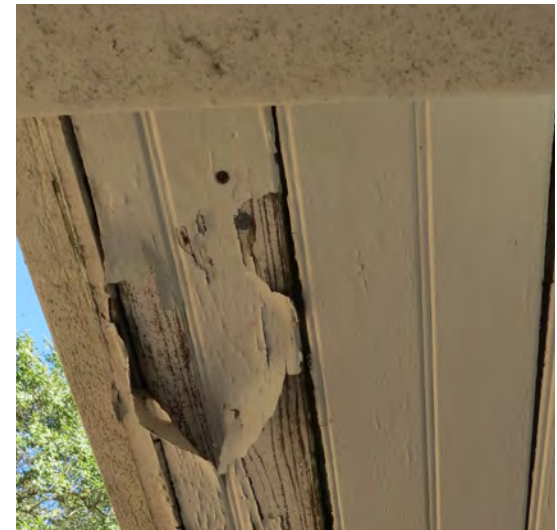
exposure (figures 292 & 293). At other locations, the paint has deteriorated from moisture intrusion, particularly where siding touches soil.

Figure 292. Peeling paint at eaves.

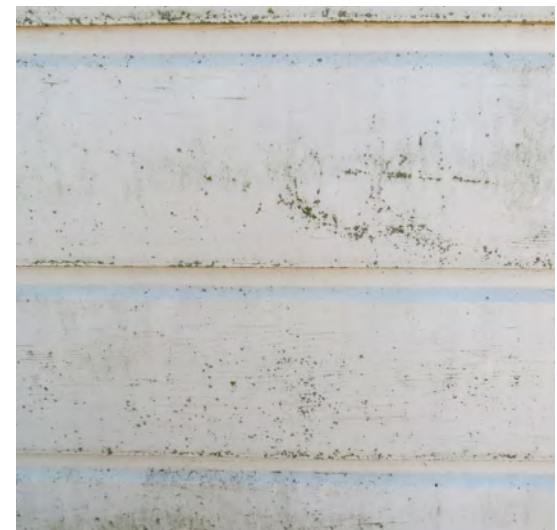
Description / Condition: Biological growth includes algae, lichen and fungi. Various types of fungi are present, evident as orange, green and black staining. These problems are evident in the staining visible at the damp, shaded areas of the exteriors. Biological organisms are not only unsightly but can, especially in the case of dry rot,

Figure 293. Biological growth on painted siding.

cause serious damage. Treat biological growth as follows:

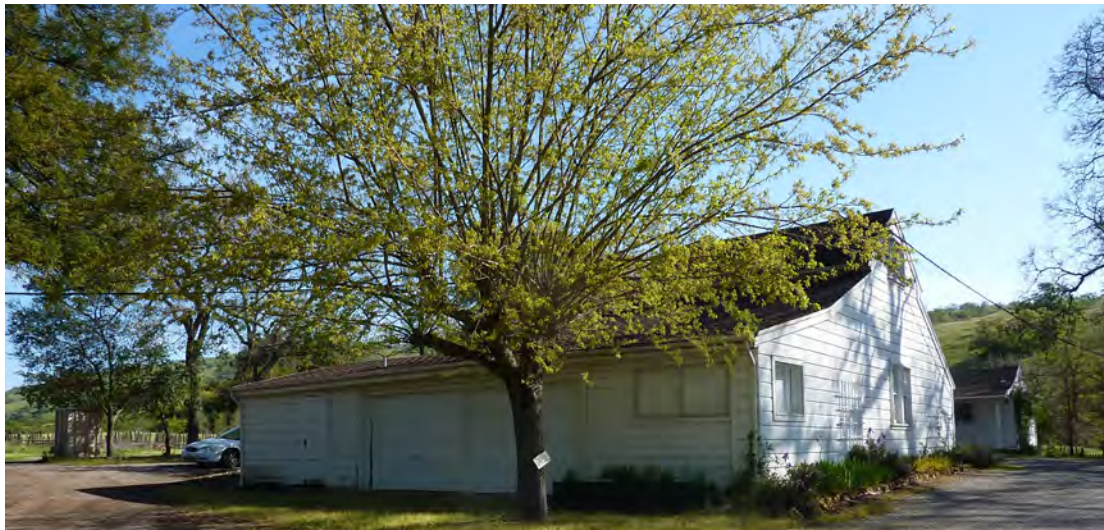
Figure 294. Vegetation surrounding the Carriage House.

plantings grow against the Carriage House on one side (figure 294). A tree grows in close proximity to the southwest elevation. Also on the southwest elevation are two trellises with climbing plants (figure 295). Several large branches from trees cantilever over the south corner of the structure. Refer to landscape matrix to identify historic plantings.

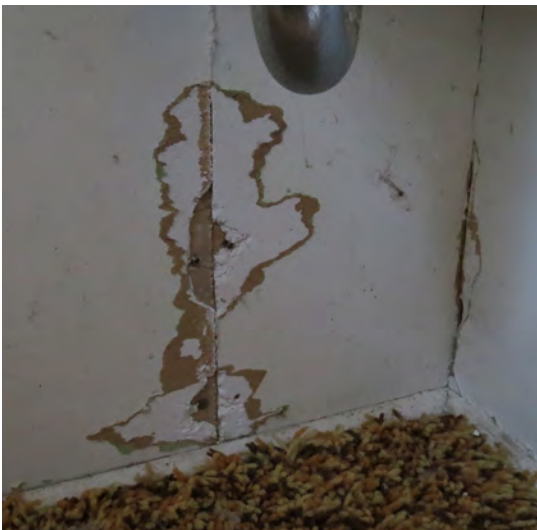
Figure 299. Crack under window in Room 110.

The bathroom (110) has a major crack under the window (figure 299). Water damage is evident below the windows in both of the bedrooms (113, 201) likely due to exterior wood deterioration. There is major damage as well in the second floor bathroom (202) beneath the sink from leaking plumbing (figure 300).

Where gypsum board is damaged from structural movement, or wear, repair as follows:

- Retain as much historic gypsum board as possible. Repair hairline cracks in sound, adhered, gypsum board with a compatible commercial patching material.
- Where large sections or panels of gypsum board

are damaged, remove area and reinstall new gypsum board to be flush with existing. Finish to match adjacent surfaces.

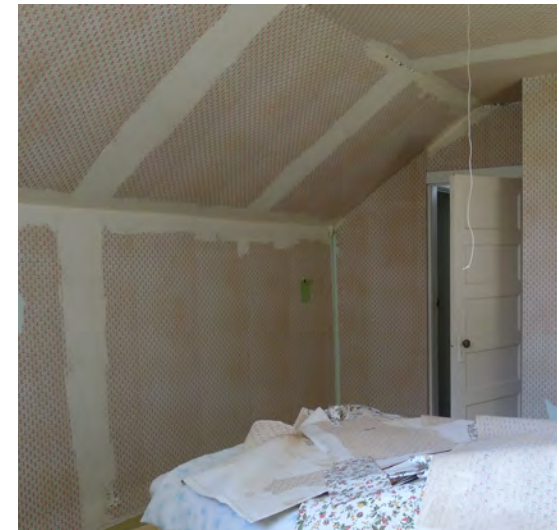
Figure 300. Gypsum board damage.

Recommendation: Where gypsum board has deteriorated from water intrusion, eliminate the source of water intrusion prior to making repairs, and repair as follows:

- Retain as much historic gypsum board as possible.
- Remove area of deteriorated gypsum board.
- Fit replacement piece of gypsum board as closely to removed area as possible.
- Prep for paint or wall paper and finish to match existing adjacent surfaces.

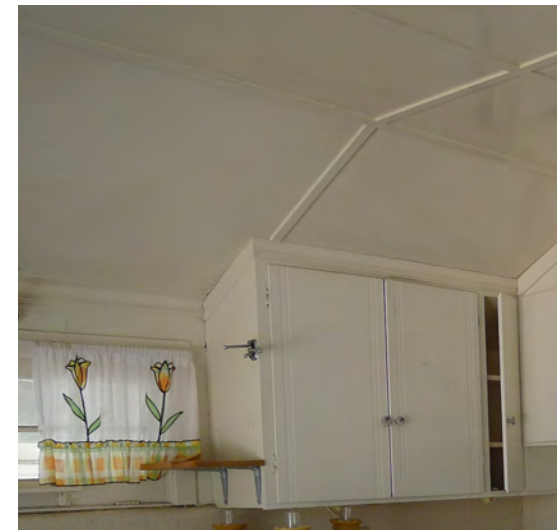
The wallpaper is in fair condition in the dining room (111) and in poor condition on the second floor (201), where the two applied layers have been ripped from the walls (figure 301).

Figure 301. Wallpaper in Room 201.

Replace deteriorated wallpaper with well-researched paper that is contemporary, but historically compatible with the building’s historic character. Treat wallpaper as follows:

- Retain as much historic wallpaper as possible.
- Survey wallpaper for damage and wear, identify areas that can be retained and reused.
- Where condition will not allow reuse, remove wallpaper using steam method, protecting adjacent finishes.
- Repair any damaged gypsum board.
- Replace wallpaper in kind or with compatible pattern and design.

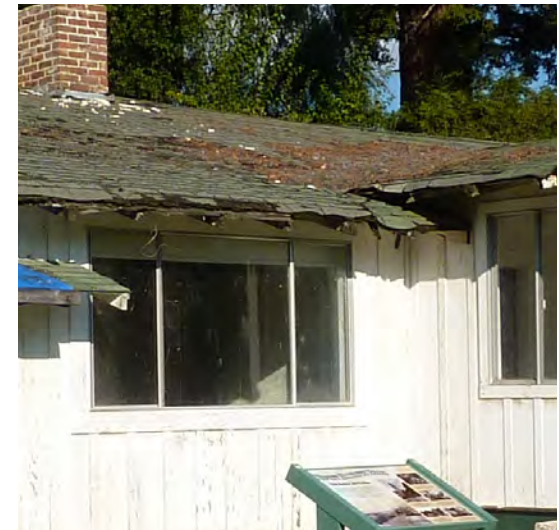
Roof surface failure has allowed water penetration at the north western corner of the building causing interior damage. Also, see the next, related section on drainage.

Figure 322. Deteriorated shingles.

Recommendations: The roof of any structure is a highly vulnerable element. It is also the first line of defense against water intrusion. Asphalt shingles have a finite life span and these assem-

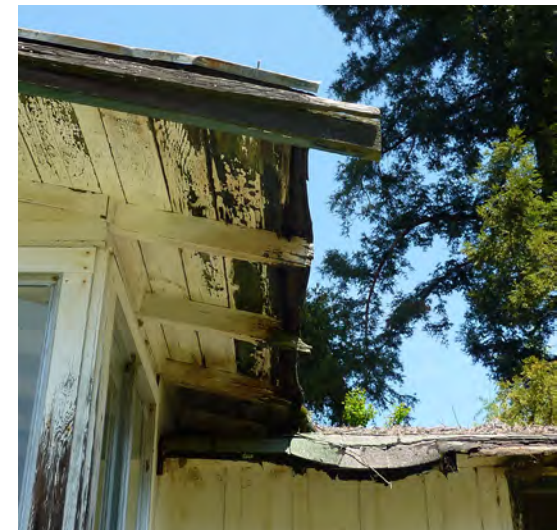
Figure 323. Deteriorated sheathing and rafters.

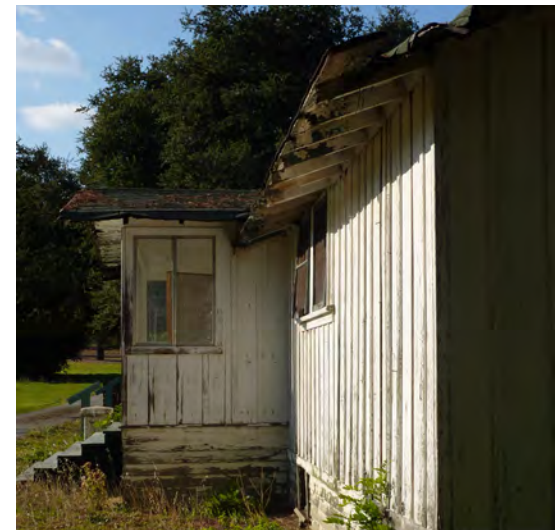
Figure 326. McCreery Cottage with no drainage system.

Description: There is no existing gutter system on this structure (figure 326).

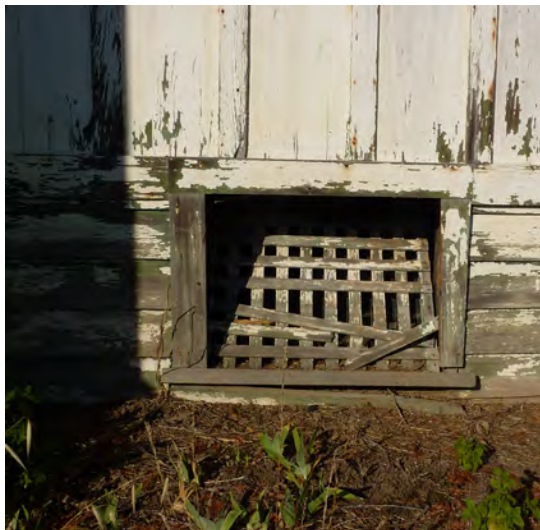
Figure 328. Deteriorated siding and broken foundation vent grille.

Condition: The cladding is in poor condition. Deterioration includes peeling and general deterioration of the paint, longitudinal cracking, water damage, dirt build-up, biological growth, and some rust staining occurring at metal attachments and penetrations. Paint is peeling from the siding and is cracking over the entire surface. In general, the paint on all exterior surfaces is systemically failing. The painted wood shiplap siding at the base of the exterior wall is in direct contact with the ground and wood deterioration is accelerated in these areas around the perimeter of the building. Mold and other biological growth are found on the painted surface, especially on the northwest side of the building on both the shiplap base and board and batten wall above. Battens are missing in several locations on the board and batten portion of the wall. Where siding and roof shingles meet at the additions wood deterioration is evident. The foundation vent grilles are broken or missing allowing vermin into the space below the floor (figure 328). The attic vent grille at the east gable end is broken allowing vermin into the attic spaces.

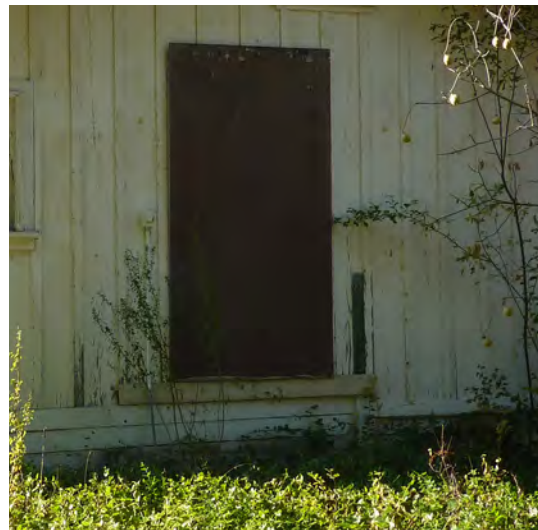
Figure 329. Boarded up door on east elevation.

Description: A large aluminum sliding door is centered at the front facing gable entry. A door opening on the east elevation is boarded up (figure 329). This door is a solid wood core door. There are no other exterior wood doors.

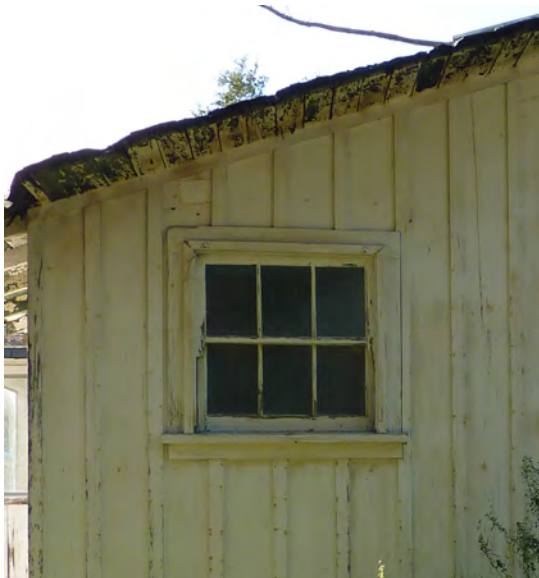
Condition: The windows are in fair condition (figure 330). The exterior paint is deteriorated at many of the windows. Joint separation between the wood members occurs at many of the windows. Much of the glazing compound is dried, cracked or missing. In addition to lead in the existing paint, asbestos may be found in the glazing compound. The frames of the aluminum windows are rusting. Windows and their sills on all sides of the building have black biological growth stains. Sills on the south elevation are severely weathered from ultraviolet exposure. No broken window panes were observed. It appears that much of the original hardware is intact, but the actual extent should be determined by a survey.

Condition: The trim around the windows and doors is weathered with deterioration similar to that of the surrounding board and batten wall (figure 330). Biological growth is primarily on the window sills and other horizontal trim members where water is allowed to stand.

Figure 330. Wood window with trim.

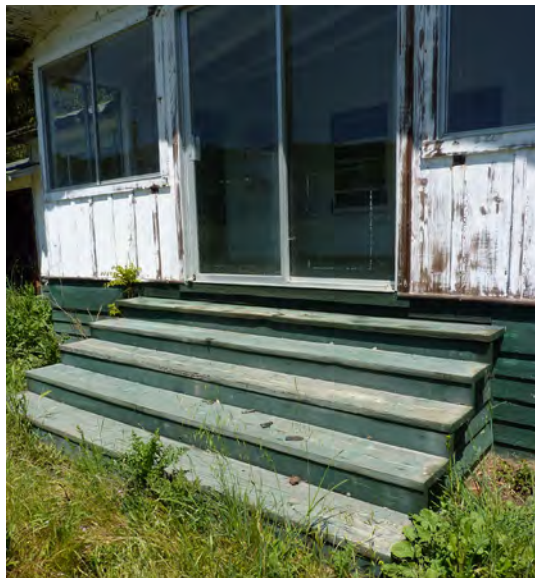
Condition: The wooden entry steps are deteriorated, and in poor condition, especially the 2x treads and the stringers below that carry the steps (figure 331). The step configuration is not currently code compliant with the presence of a sliding glass door at the top step. The original entry steps leading to the exterior door of Room 104 are missing.

Figure 331. Wooden entry steps.

- Dismantle stair.
- Determine if any pieces can be reused and replace those that can not in-kind.
- Reconstruct entry stair and landing using historic photographs as reference. Stair should match historic stair condition at the porch entry. The addition of code compliant railings may be considered in the event of future public use.
- Reconstruct missing stair and landing at north western elevation based on historic photographs.

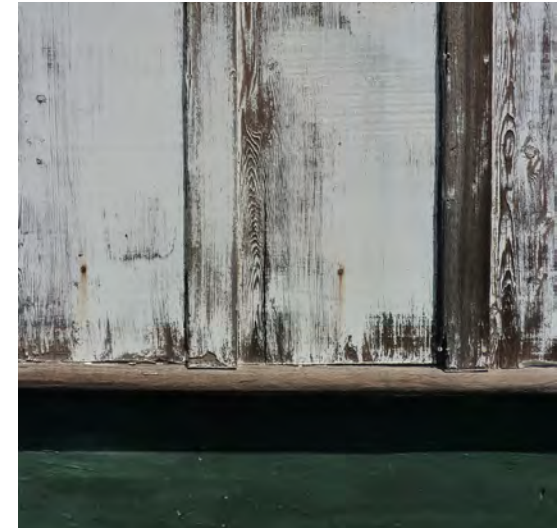
Condition: The paint has deteriorated, and displays cracking, peeling, or missing conditions caused by natural weathering and ultraviolet light exposure (figures 333 & 334). At other locations, the paint has deteriorated from moisture intrusion, particularly where siding touches soil. Paint recommendations are as follows:

Figure 334. Paint deterioration.

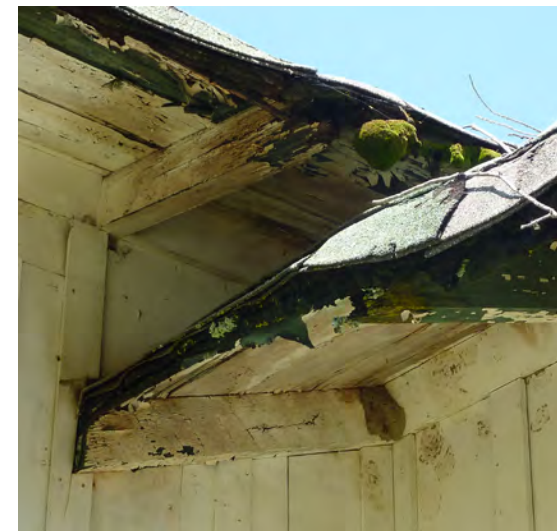
Description / Condition: Biological growth includes algae, lichen and fungi. These problems are evident in the staining visible at the damp, shaded areas of the exteriors (figure 335). Various types of fungi are present, evident as orange, green and black staining. Biological organisms are not only unsightly but can, especially in the case of dry rot, cause serious damage.

Figure 335. Biological growth.

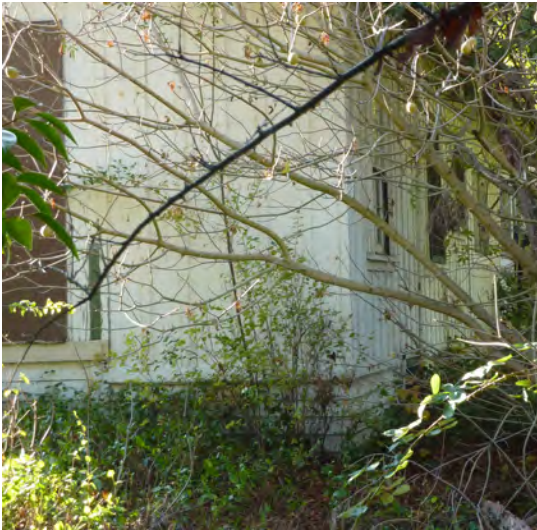
Condition: The vegetation along the northwest and northeast elevations appears to be minimally maintained (figure 336). The trees could potentially cause damage in the event of strong winds. At the time of the survey there was a large tree branch that had fallen on the roof. Many large bushes surround the building and are close enough to hold moisture against the wood surfaces. Bushes close the structure also support biological growth.

Figure 336. Vegetation close to McCreery Cottage along the northeast elevation.

vegetation can hold moisture against the building, providing an ideal climate for biological growth, accelerating wood deterioration.
