HISTORIC STRUCTURES REPORT

GRANT RANCH HOUSE COMPLEX

JOSEPH D. GRANT COUNTY PARK

Final Report
November 7, 2012

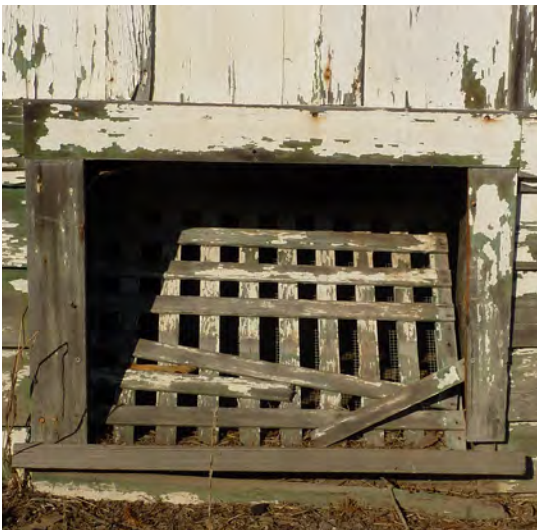
Figure 337. Damage vent at foundation where pests can enter the crawl space area.

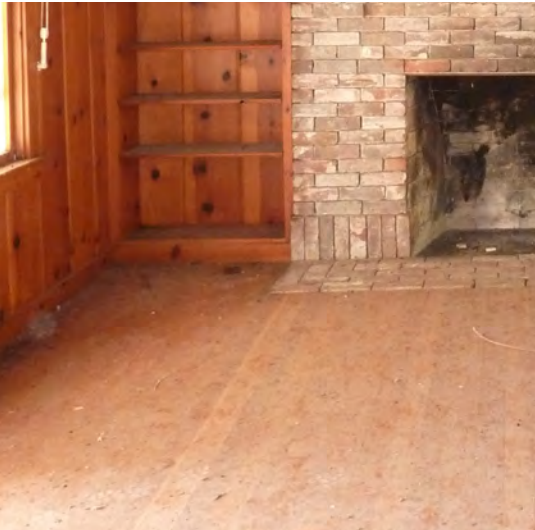
Condition: The wood floors appear to be in sound condition, although the clear finish is scratched and worn (figure 338). Staining also occurs due to rodent droppings. If wood floor exists beneath the carpet, it is likely in good condition. Sheet vinyl is scratch, stained, and curling around the

Figure 338. Wood floor in Living Room.

Recommendations: Remove non-contributing vinyl floor finishes and carpet.

Repair wood flooring as follows:

- Survey floors in detail for damage. Conduct finish analysis on wood floors to determine historic finishes.
- Use the gentlest means possible to remove adhesives from areas beneath the vinyl or carpet. Use all legal means in handling and disposal of asbestos-containing materials.
- Repair wood floors. Patch damaged areas in kind (Pine or Oak). Clean existing finish if possible, or refinish to match historic treatment. Refinishing should be limited to severely worn areas, since excessive refinishing shortens the lifespan of the flooring.
- If wood floors must be removed for the structural upgrade, carefully salvage boards for reuse in the same locations.
- Refinish floors with a clear coat.

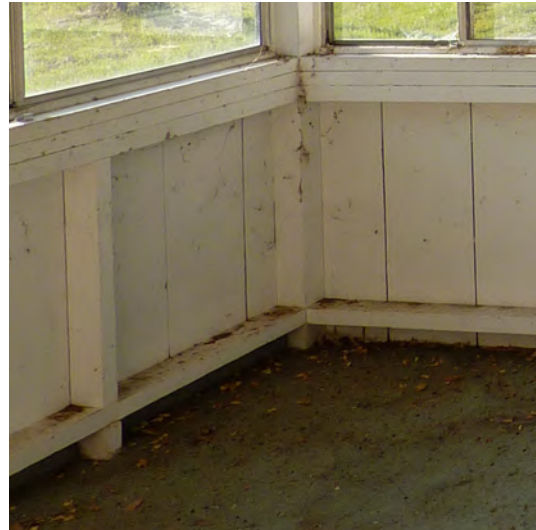
Figure 339. Enclosed Porch with worn carpet.

edges. The carpet is also worn and stained from rodent droppings (figure 339).

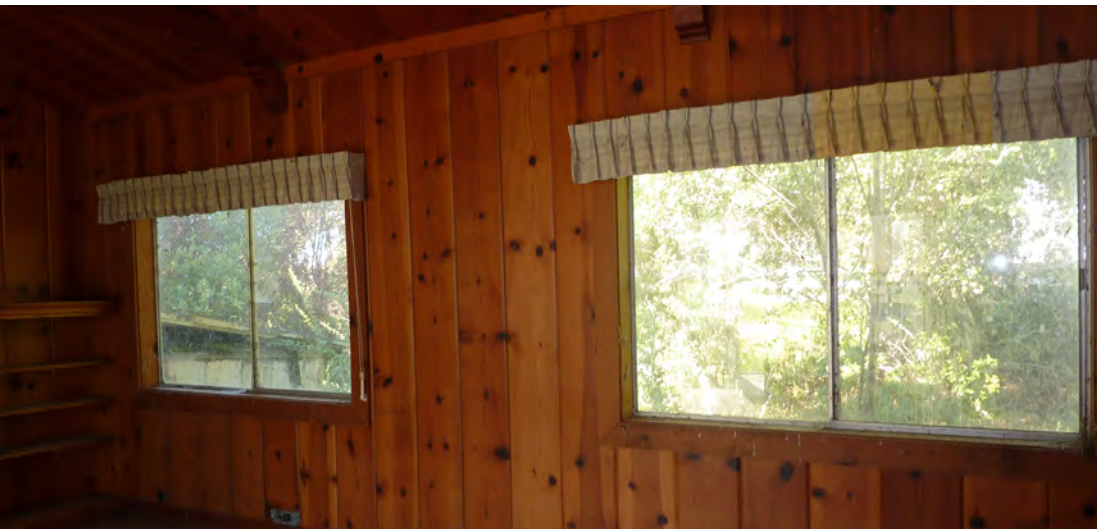
Figure 340. Knotty pine wood paneling in Living Room.

Condition: McCreery Cottage walls vary in condition from good to poor. The knotty pine paneling and the painted board and batten are in good condition with some general wear. The Sheetrock is in overall good condition, but material failure has occurred in bathroom 105 where water intrusion from roofing failure destroyed the surfaces of the north wall. The ceramic tile in the shower has only minor cracking.

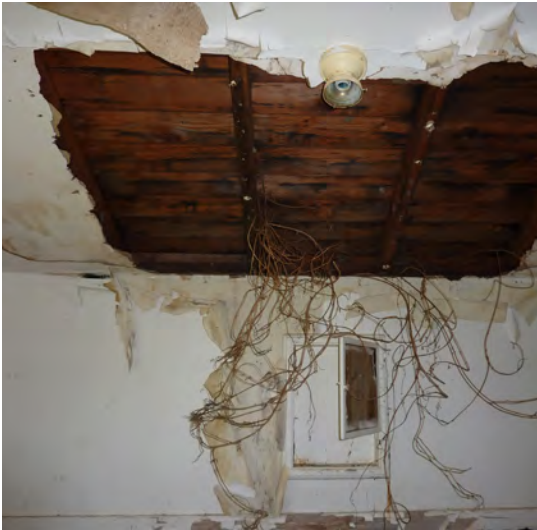
Figure 343. Damaged gypsum board ceiling in Room 105.

The gypsum board ceiling is in good repair except in bathroom 105 where water intrusion from roof cladding failure has destroyed the ceiling (figure 343).

Recommendation: Where gypsum board has deteriorated from water intrusion, eliminate the source of water intrusion prior to making repairs, and repair as follows:

- Retain as much historic gypsum board as possible.
- Remove area of deteriorated gypsum board.
- Fit replacement piece of gypsum board as closely to removed area as possible.
- Prep for paint or wall paper and finish to match existing adjacent surfaces.

Where gypsum board is sound and paint is damaged or deteriorating, repair as follows: Following thorough preparation, including the removal of loose, flaking or chalking paint, prime the walls using a high-quality primer. Follow with two coats of quality paint appropriate to its substrate. Since most of the existing paint likely contains lead, follow all regulations for worker protection and material disposal. In most cases, well-adhered lead paint may be left in place and encapsulated, rather than completely abated.

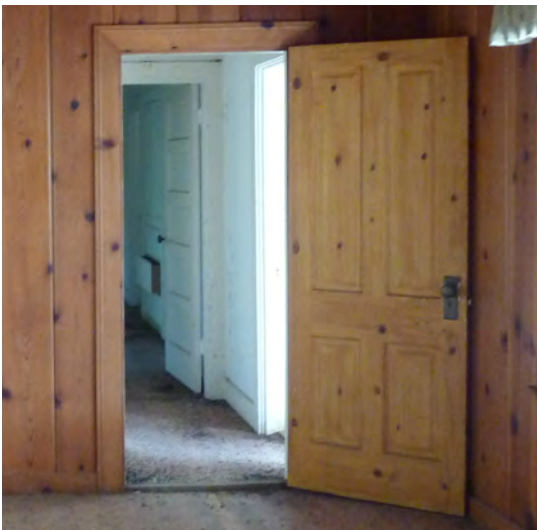
Figure 344. Four-panel door with five-panel door in the background.

Condition: The McCreery Cottage doors are in good condition with moderately worn surfaces. The faux finish on the living room doors is in good condition.

Recommendation: Restore, repair and re-use existing wood doors.

- Reuse existing doors in situ wherever possible. Avoid relocating doors and openings.
- Conduct a detailed, door-by-door survey to document condition of each door and determine, on an individual basis, required repairs

- Remove paint and refinish to match original where necessary. Carefully remove, salvage, label and appropriately store any doors, hardware and trim that must be removed.
- Fully utilize alternative door width standards available under the Americans with Disabilities Act and the State Historical Building Code.
- Replace non-historic doors with original doors from the building that are stored on site. If there are an insufficient number of historic doors, use period appropriate door types that are compatible with, but distinct from the historic doors.

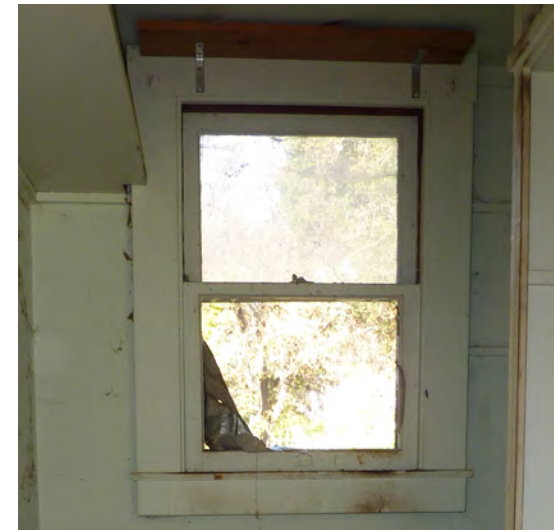
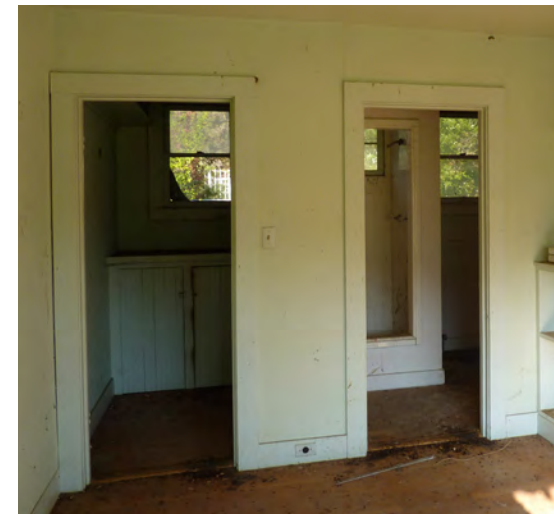
Figure 345. Flat trim around window.

Figure 346. Flat trim around door openings.

Condition: Interior wood trim in McCreery Cottage is in fair condition. The flat door and window trim exhibits moderate wear. Paint is peeling from all trim surfaces except in room 102.

Recommendations: Retain, repair and re-use original wood trim and paneling components. Restore deteriorated or damaged wood elements as follows:

- Repair any splits, gouges, or large chips. Use Dutchman patches for clear finished wood Epoxy consolidant with a repair compound

- Replace missing trim that has been removed during alterations. Match original with respect to profile, wood type and finish.
- Remove non-historic vinyl base material and mastic to expose the original wood surface.
- Replace wood trim elements damaged or destroyed by water intrusion only after the source of water is eliminated.

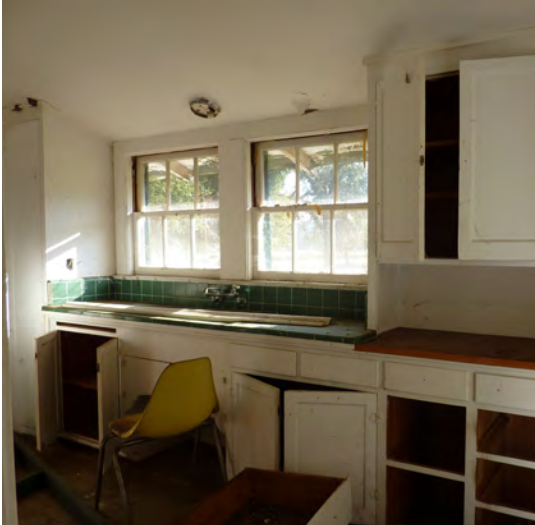
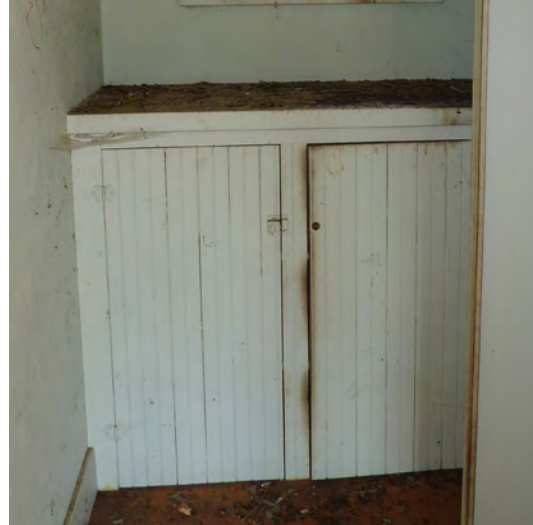
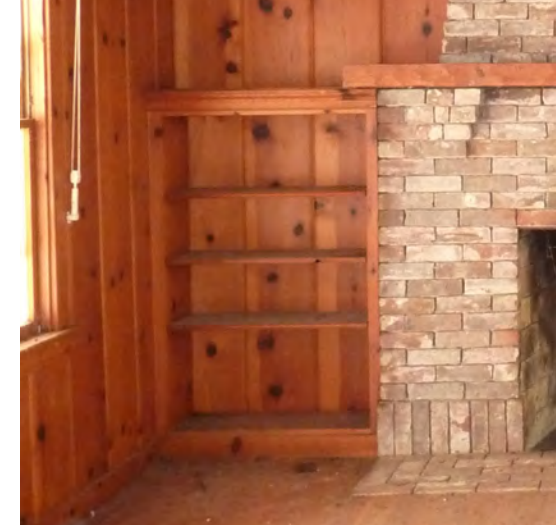
Figure 347. Cabinets in the Kitchen.

Figure 348. Cabinet in Room 106A.

Figure 349. Built-in shelves at fireplace.

Condition: The built-in cabinetry is in good condition overall. All elements are worn but function properly. In the kitchen, the drawers have been removed but all appear to be present. All cabinets have been subject to severe rodent infestation and are soiled with droppings. Hardware is slightly rusted and numerous door and drawer pulls are missing.

Recommendations: Retain, repair and re-use original wood cabinetry and casework. Restore and re-use extant historic hardware in-situ. Restore deteriorated or damaged wood elements as follows:

- Repair any splits, gouges, or large chips. Use Dutchman patches on clear finished wood. Where wood is painted epoxy consolidant with a repair compound formulated for wood may be used.
- Carefully remove, salvage, label and store any components that must be removed for other work. Return these elements to their original locations when work is finished.
- Replace missing components that has been removed during alterations. Match original with respect to profile, wood type and finish.
- Replace wood trim elements damaged or destroyed by water intrusion only after the source of water is eliminated.

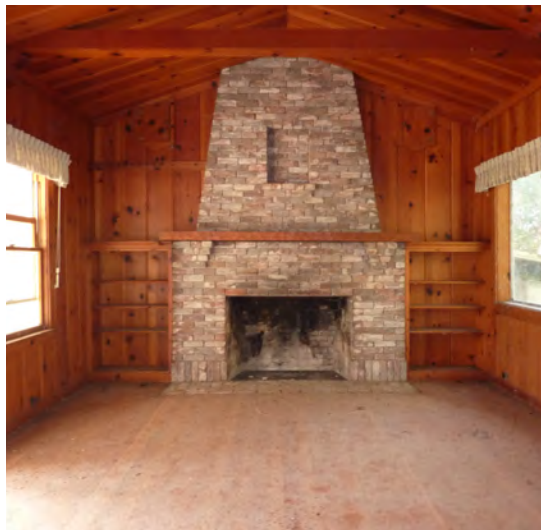
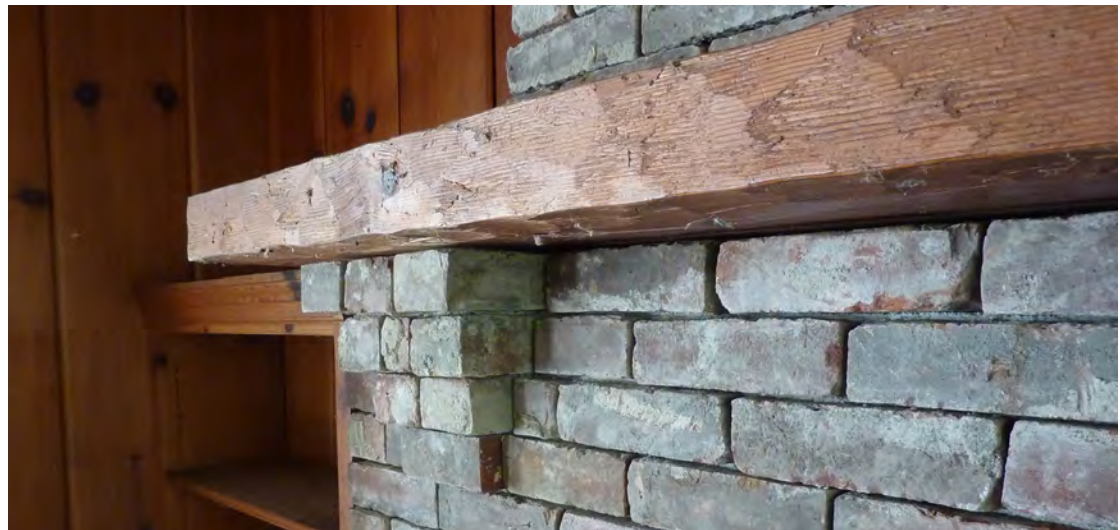
Figure 350. Brick fireplace in Living Room.

Figure 351. Wood mantel supported by a protruding brick corbel.

Condition: The fireplace in McCreery Cottage is in good condition with no visible cracks in the brick or failure in the mortar joints.

Recommendations: Currently, there is no major damage to the fireplace. Clean the soot stains on the surrounds and mantels using the gentlest means possible. Conduct a detailed survey to determine any area of needed repair, and address brick repairs as follows:

Masonry Repointing. Repoint deteriorated, loose, missing and improperly installed mortar.

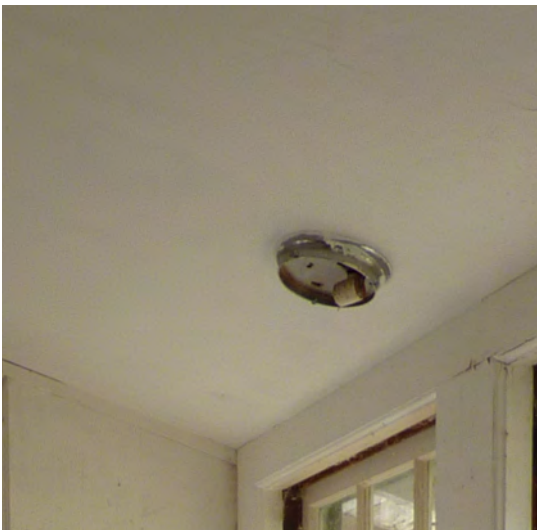
Figure 353. Light fixture in Kitchen.

Condition: The two extant lighting fixtures are in poor condition. The rings are rusted and both globes are missing (figure 353).
